IDORA MILL AND RED MONARCH MINE
Idaho Panhandle National Forests

SITE INVESTIGATION - FINAL

Prepared by
MCS Environmental, Inc.
5562 Alloy South
Missoula, MT 59808

May 10, 2004
110018.013.0

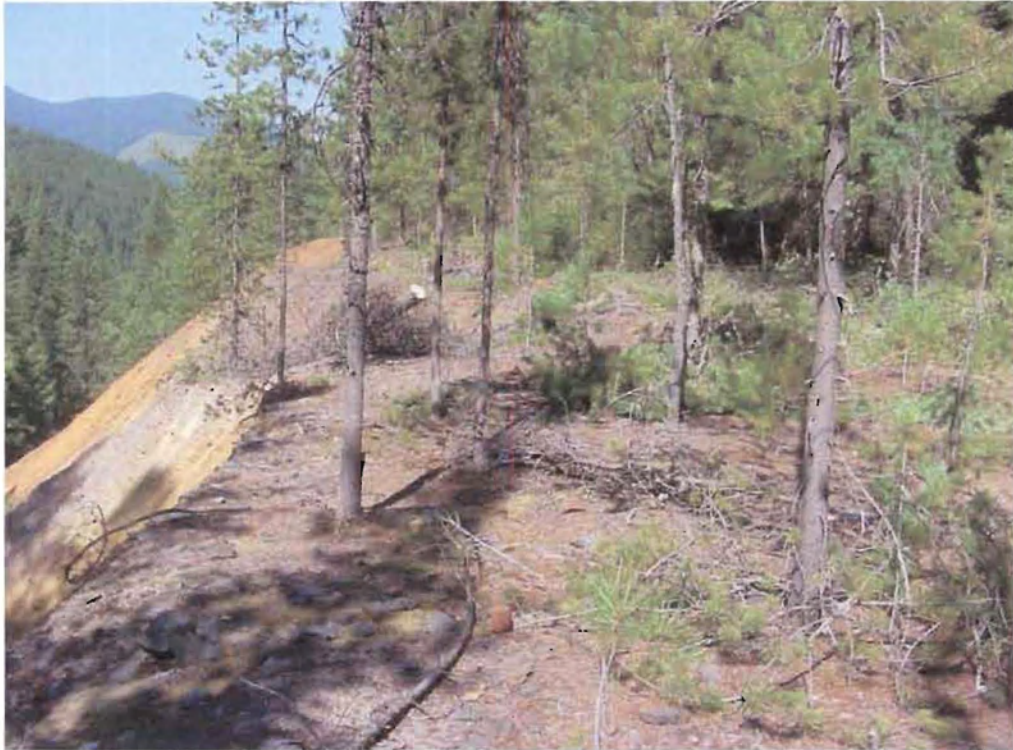
Photo 1: Top of Red Monarch waste rock dump.

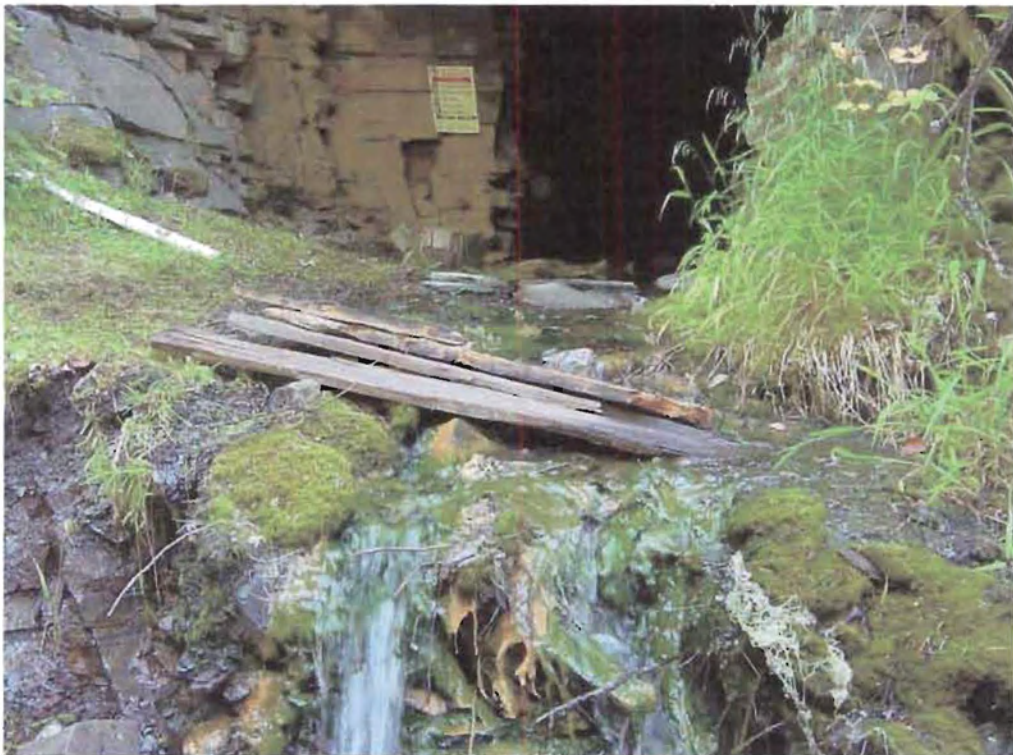
Water flowing from the adit at the Red Monarch Mine contains elevated concentrations of cadmium (0.0071 mg/L), lead (0.070 mg/L), and zinc (2.18 mg/L). High concentrations of cadmium (27.9 mg/kg), copper (50.9 mg/kg), lead (674 mg/kg), and zinc (18,000 mg/kg) are found in the sediments at the location of where the water flows from the adit. Metals in the sediment have the adit discharge as their likely source through precipitation reactions as the adit water is exposed to oxygen.

Photo 2: Adit discharge at the Red Monarch Mine.

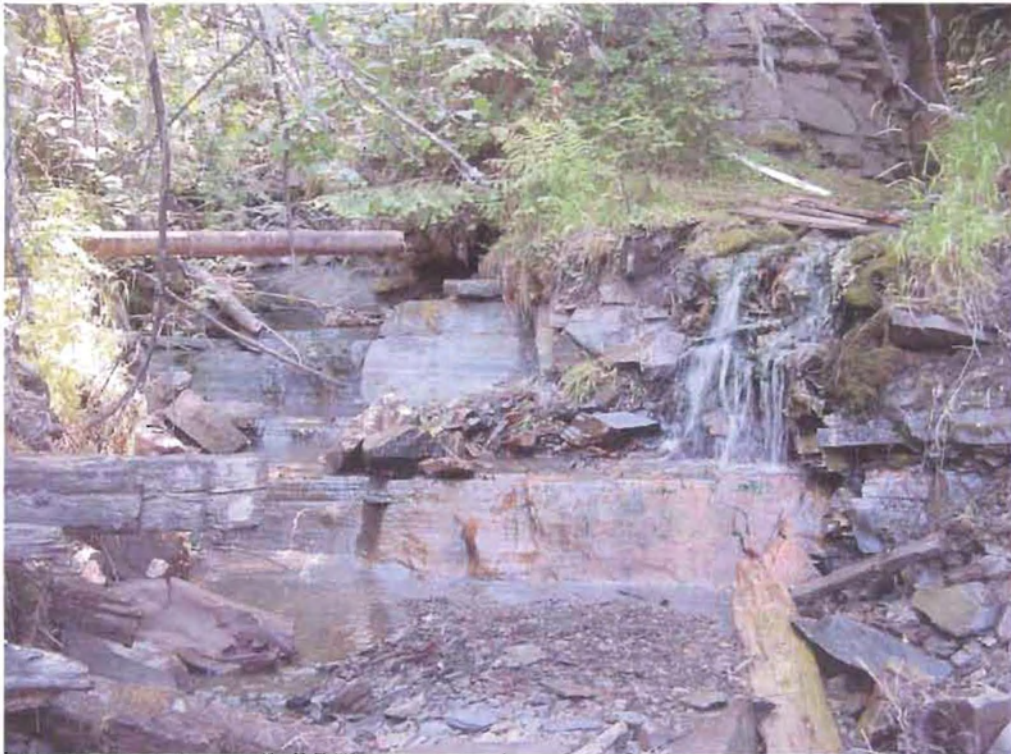
Photo 3: Missoula Gulch below Red Monarch adit. Adit discharge is on the right.

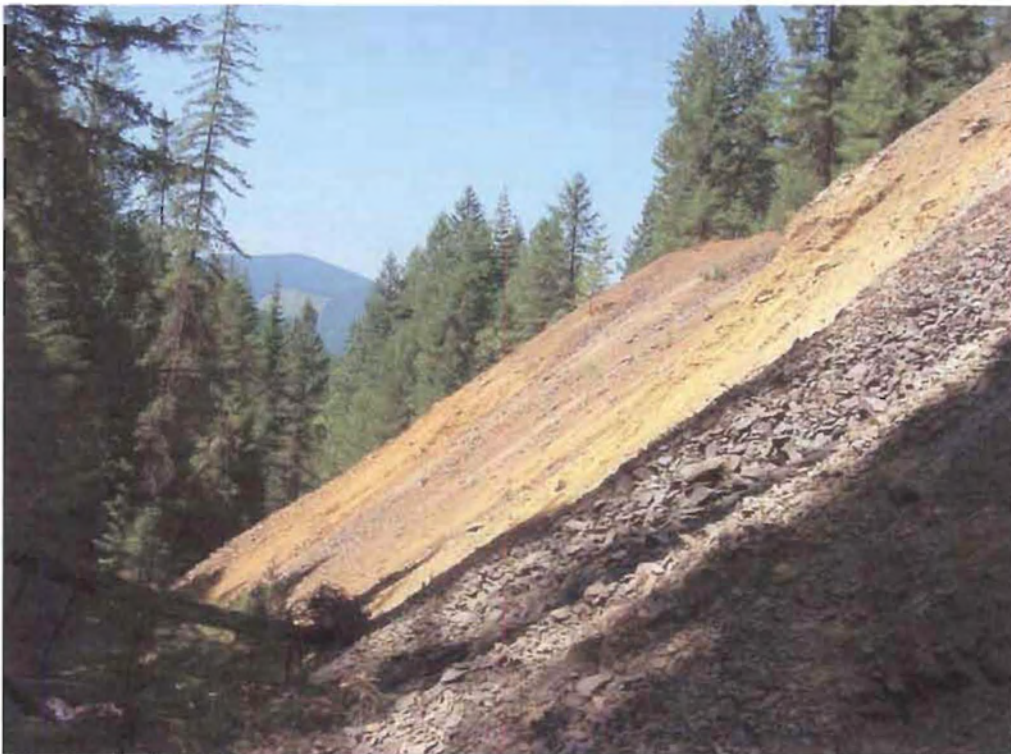
Waste rock at the Red Monarch Mine contains minor amounts of the metals. The first waste rock excavated from the adit was placed in lobe 1. Metals concentrations in lobe 1 are very low and probably similar to background. Metals concentrations increase in lobes 2 and 3. Table 6.1 contains the highest concentrations of individual metals found at the site along with cleanup levels derived by TetraTech (1996) for the Montana Department of Environmental Quality (MDEQ) and updated by MCS (2003). Cleanup guidelines are from the rockhound/gold panner scenario with maximum exposure of 50 days per year. Reference cleanup guidelines for arsenic and lead from the Bunker Hill Record of Decision (ROD) (EPA 2002b) are also included in the table. Arsenic and lead concentrations are below the ROD and MDEQ cleanup guidelines.

Photo 4: Red Monarch waste rock dump viewed from Missoula Gulch.

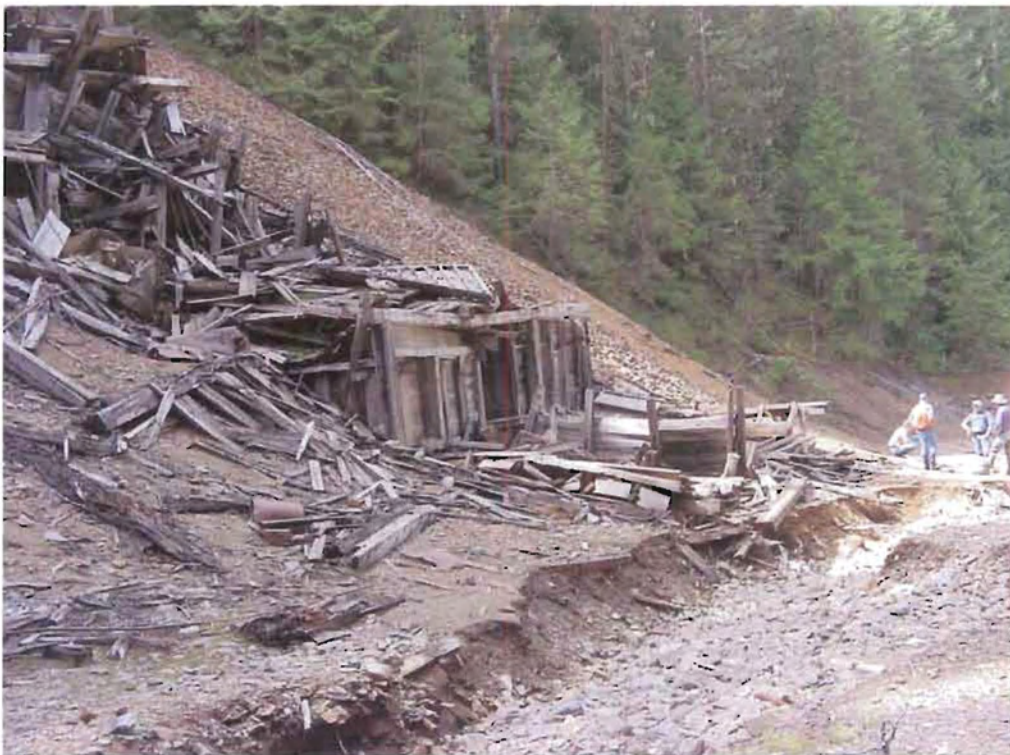
reportedly on the hillside above the mill. Tailings at one time apparently covered the narrow valley bottom. The creek has since eroded a channel through the tailings. Floods and seasonal high water actively erode the tailings to downstream areas. Tailings appear to have impacted the stream sediments for an undetermined distance from the mill.

Photo 6: Idora Mill with recently eroded channel.

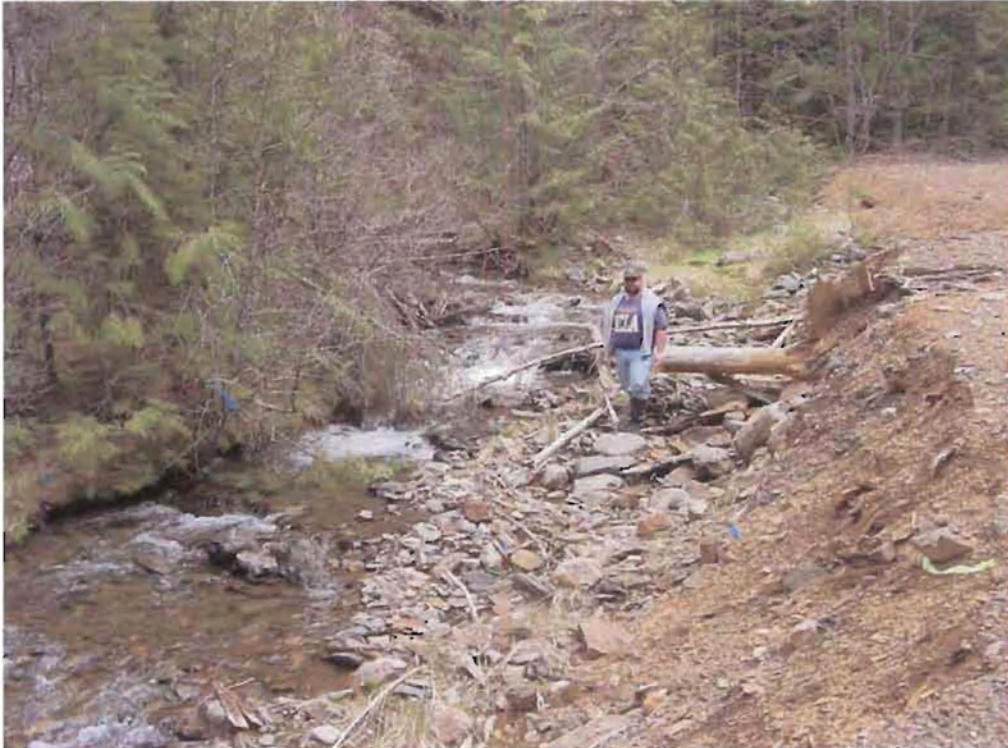
Photo 7: Beaver Creek at the lower end of the Idora Mill site.

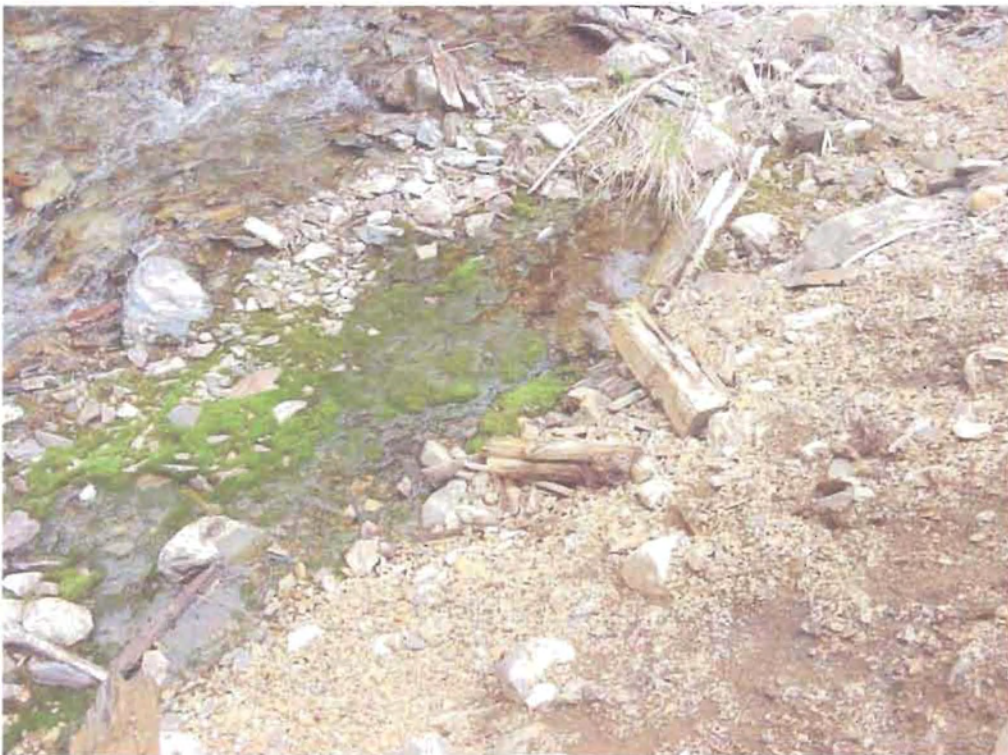
A significant groundwater recharge reach is located a short distance above the Idora Mill at the debris dam. Groundwater discharges to the creek below the debris dam and a spring was observed adjacent to the creek opposite the mill. A significant groundwater discharge area is located at the lower end of the tailings (Photo 8). Much more groundwater was discharging from the lower end of the tailings on May 9, 2003 during the first site visit than in late July. The nature of the local groundwater system with a discharge area at the lower end of the tailings facilitates the migration of metals to Beaver Creek.

Photo 8: Seep at the lower end of the Idora Mill site.
