SITE INSPECTION REPORT

Minnie Moore Mine Site Blaine County, Idaho

Herrera Environmental Consultants, Inc.

February 18, 2004

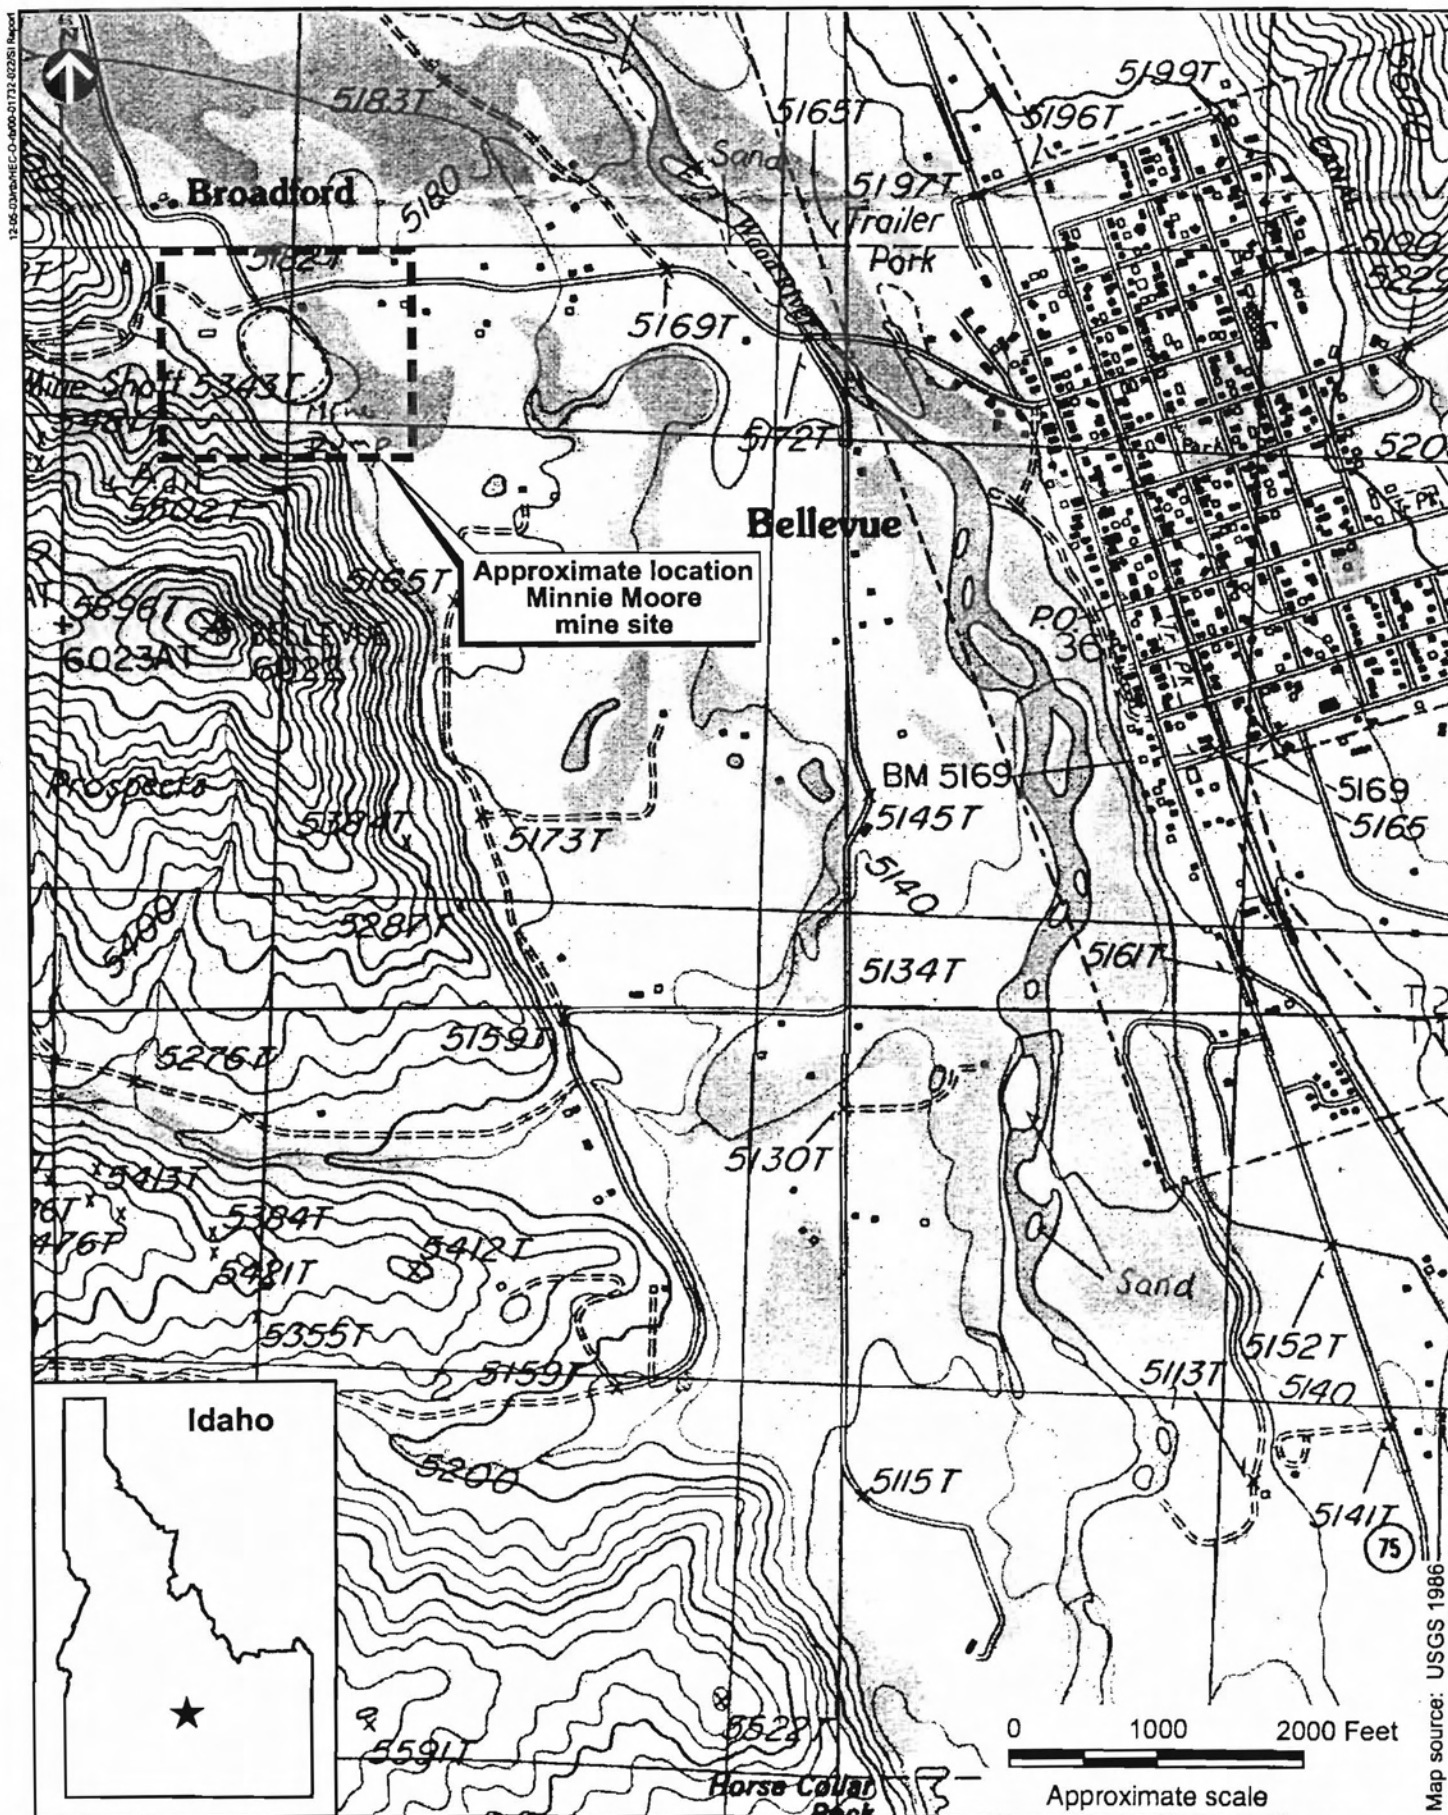
Figure 2-1. Vicinity map of the Minnie Moore mine site, Blaine County, Idaho.

The Minnie Moore Mine is located about 1.5 miles west of Bellevue, Idaho in the Mineral Hill mining district of the Big Wood River Valley (Figure 2-1). The mine is at the mouth of Minnie Moore Gulch, formerly Galena Gulch, at an elevation of 5,300 feet above sea level. The site consists of the remains of a mill, the burned remains of a shop, a bunkhouse, a domestic well, a tailings pile, and two dry tailings overflow ponds (Figure 2-2).

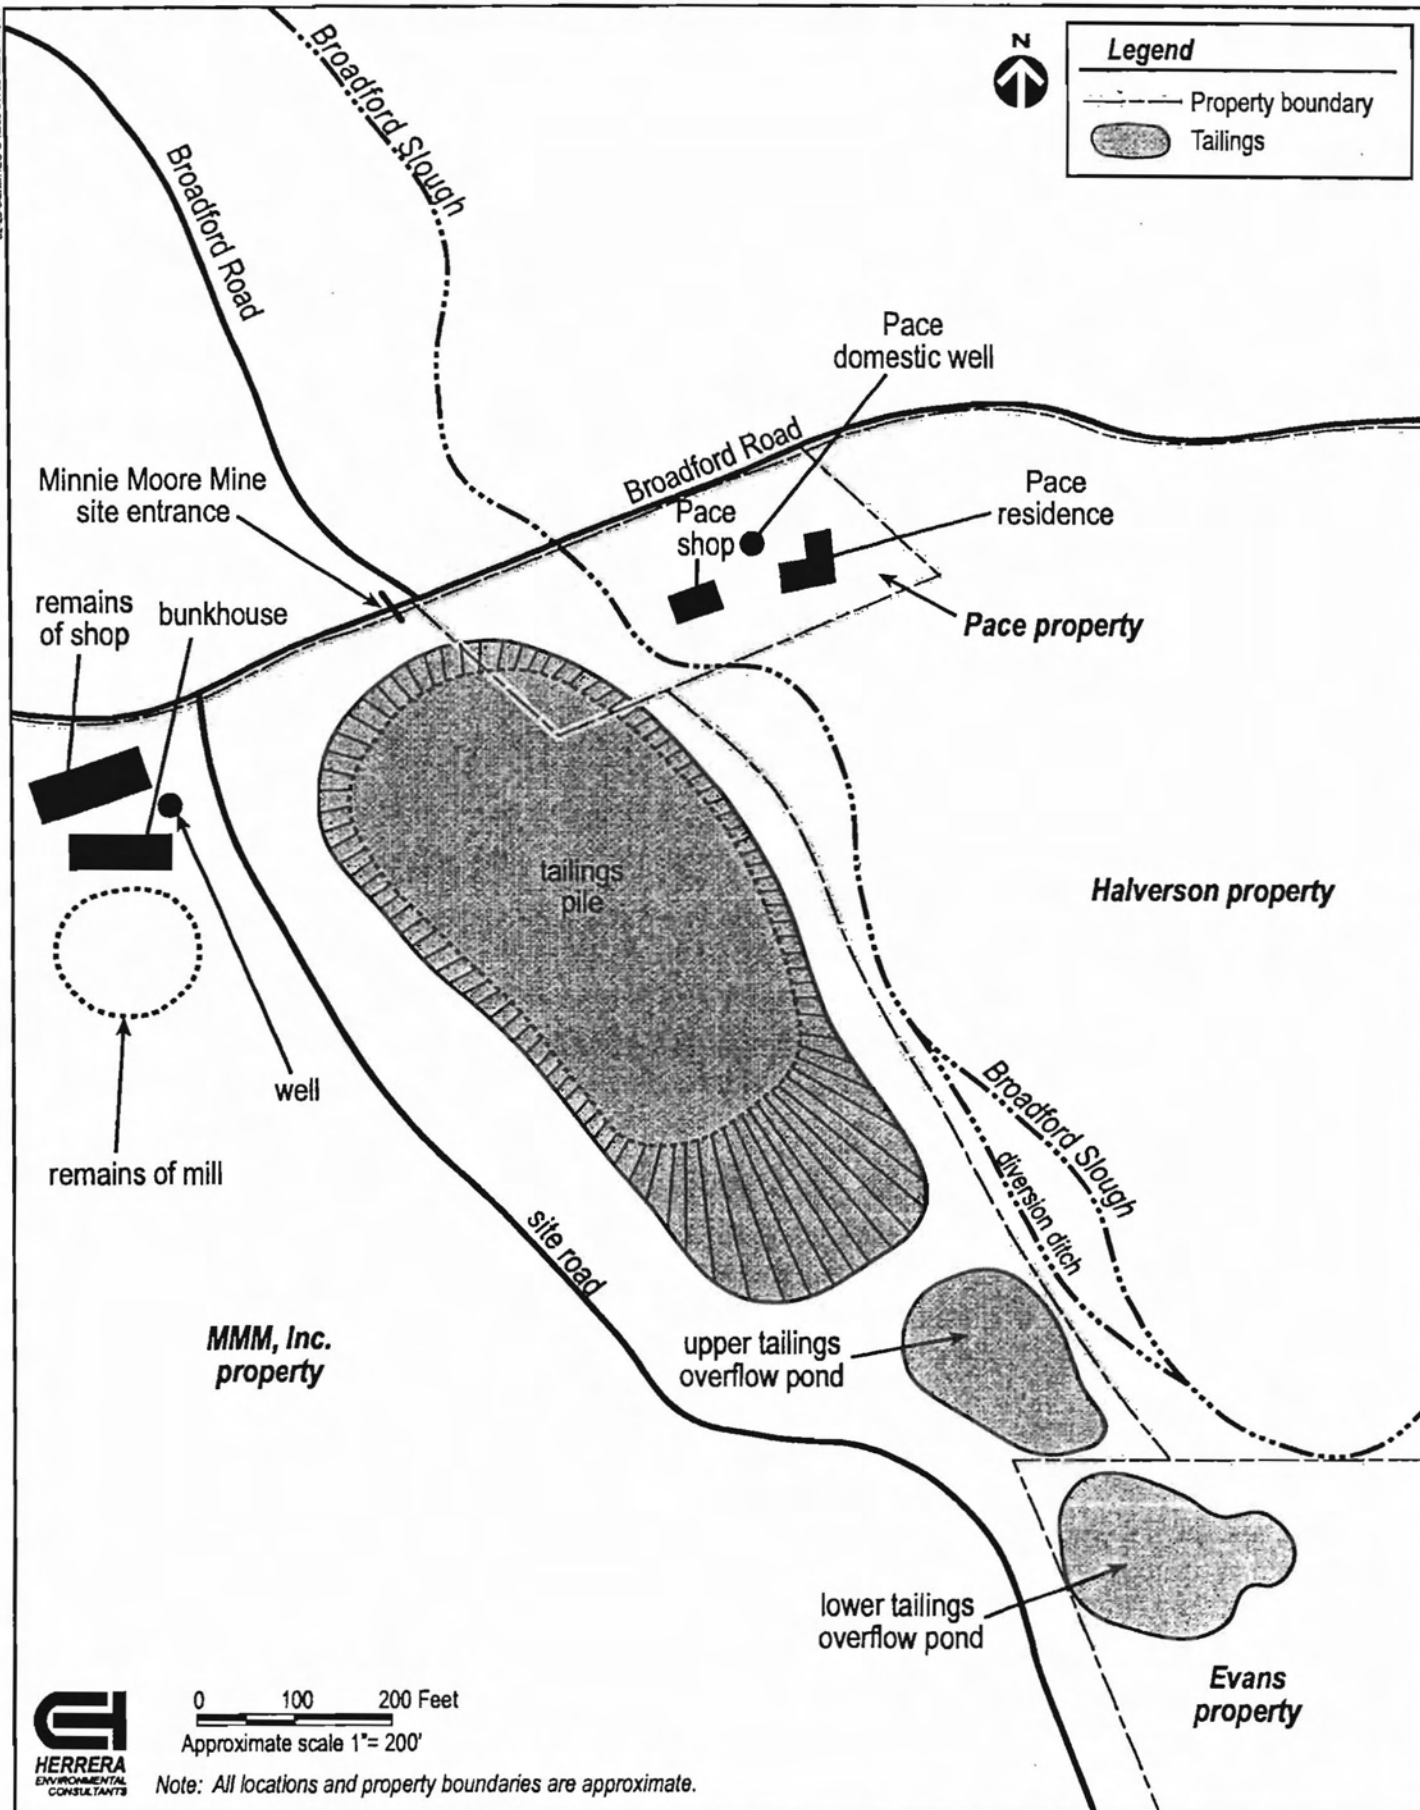
Figure 2-2. Site map of the Minnie Moore Mine site, Blaine County, Idaho.

A roughly rectangular tailings pile is located just south of the site entrance from Broadford Road. It is about 20 feet tall and covers an area of approximately 6 acres. It is bordered to the east by Broadford Slough. The tailings are the waste product that resulted from operations at the former onsite mill. Ores from the mines were processed to extract silver and other minerals of value, leaving the fine-grained, gray tailings.

Two dry tailings overflow ponds are present southeast of the tailings pile. The two ponds are currently separated by a rock berm constructed by Mr. Evans to mark the boundary of his property, according to Mr. Johnston. In some areas, a white crystalline material that appears to have precipitated from the tailings was visible on the surface of the ponds.

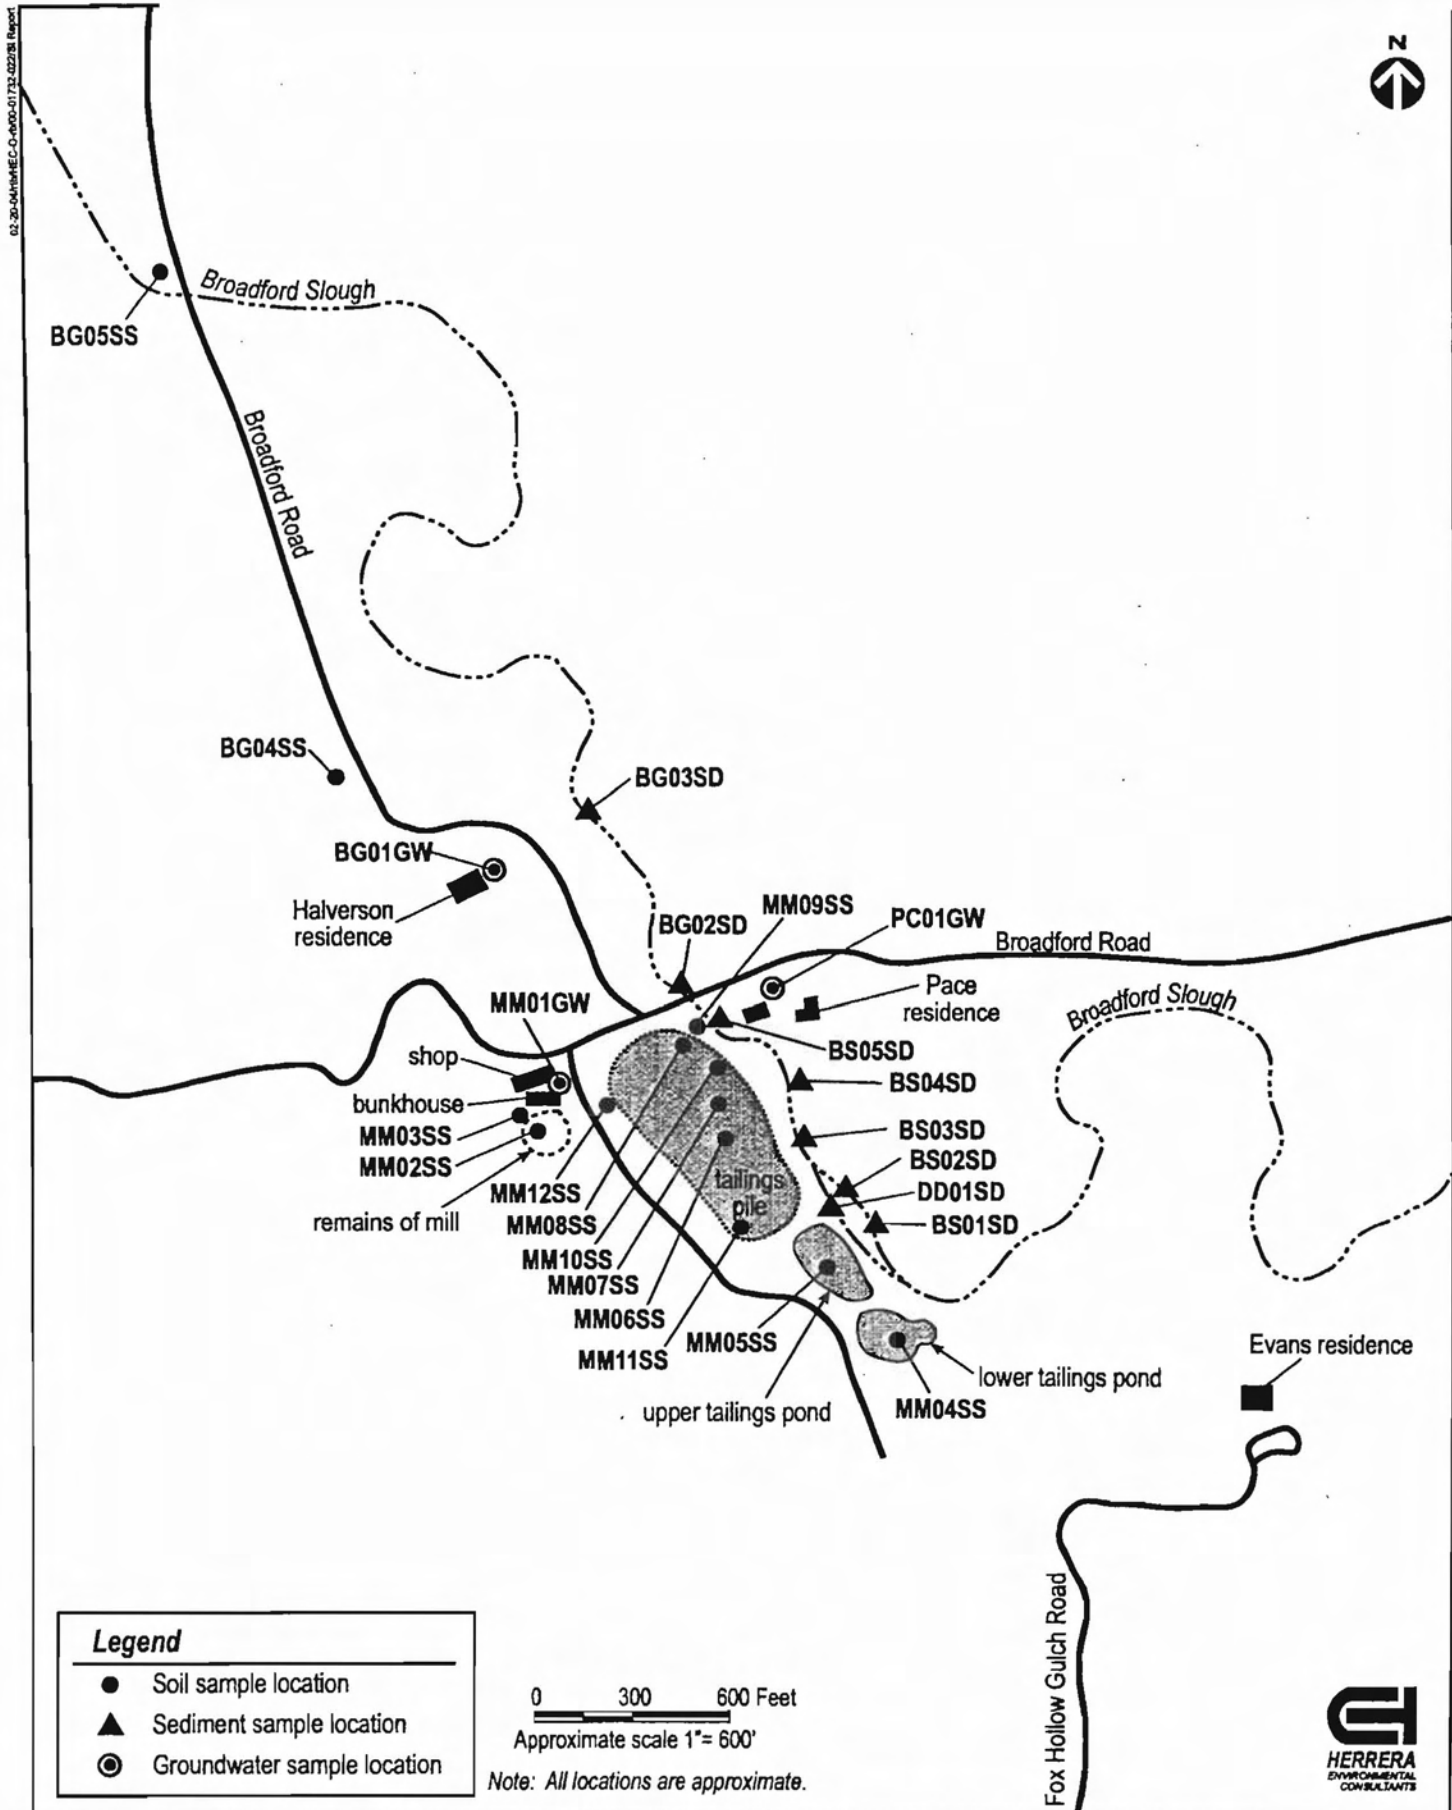
Figure 3-1. Sampling locations for the Minnie Moore Mine site, Blaine County, Idaho.

Alphanumeric identification numbers applied by the START to each sample location (e.g., MM01SS) are used in the report as the sample location identifiers. Sample locations are provided in Figure 3-1.

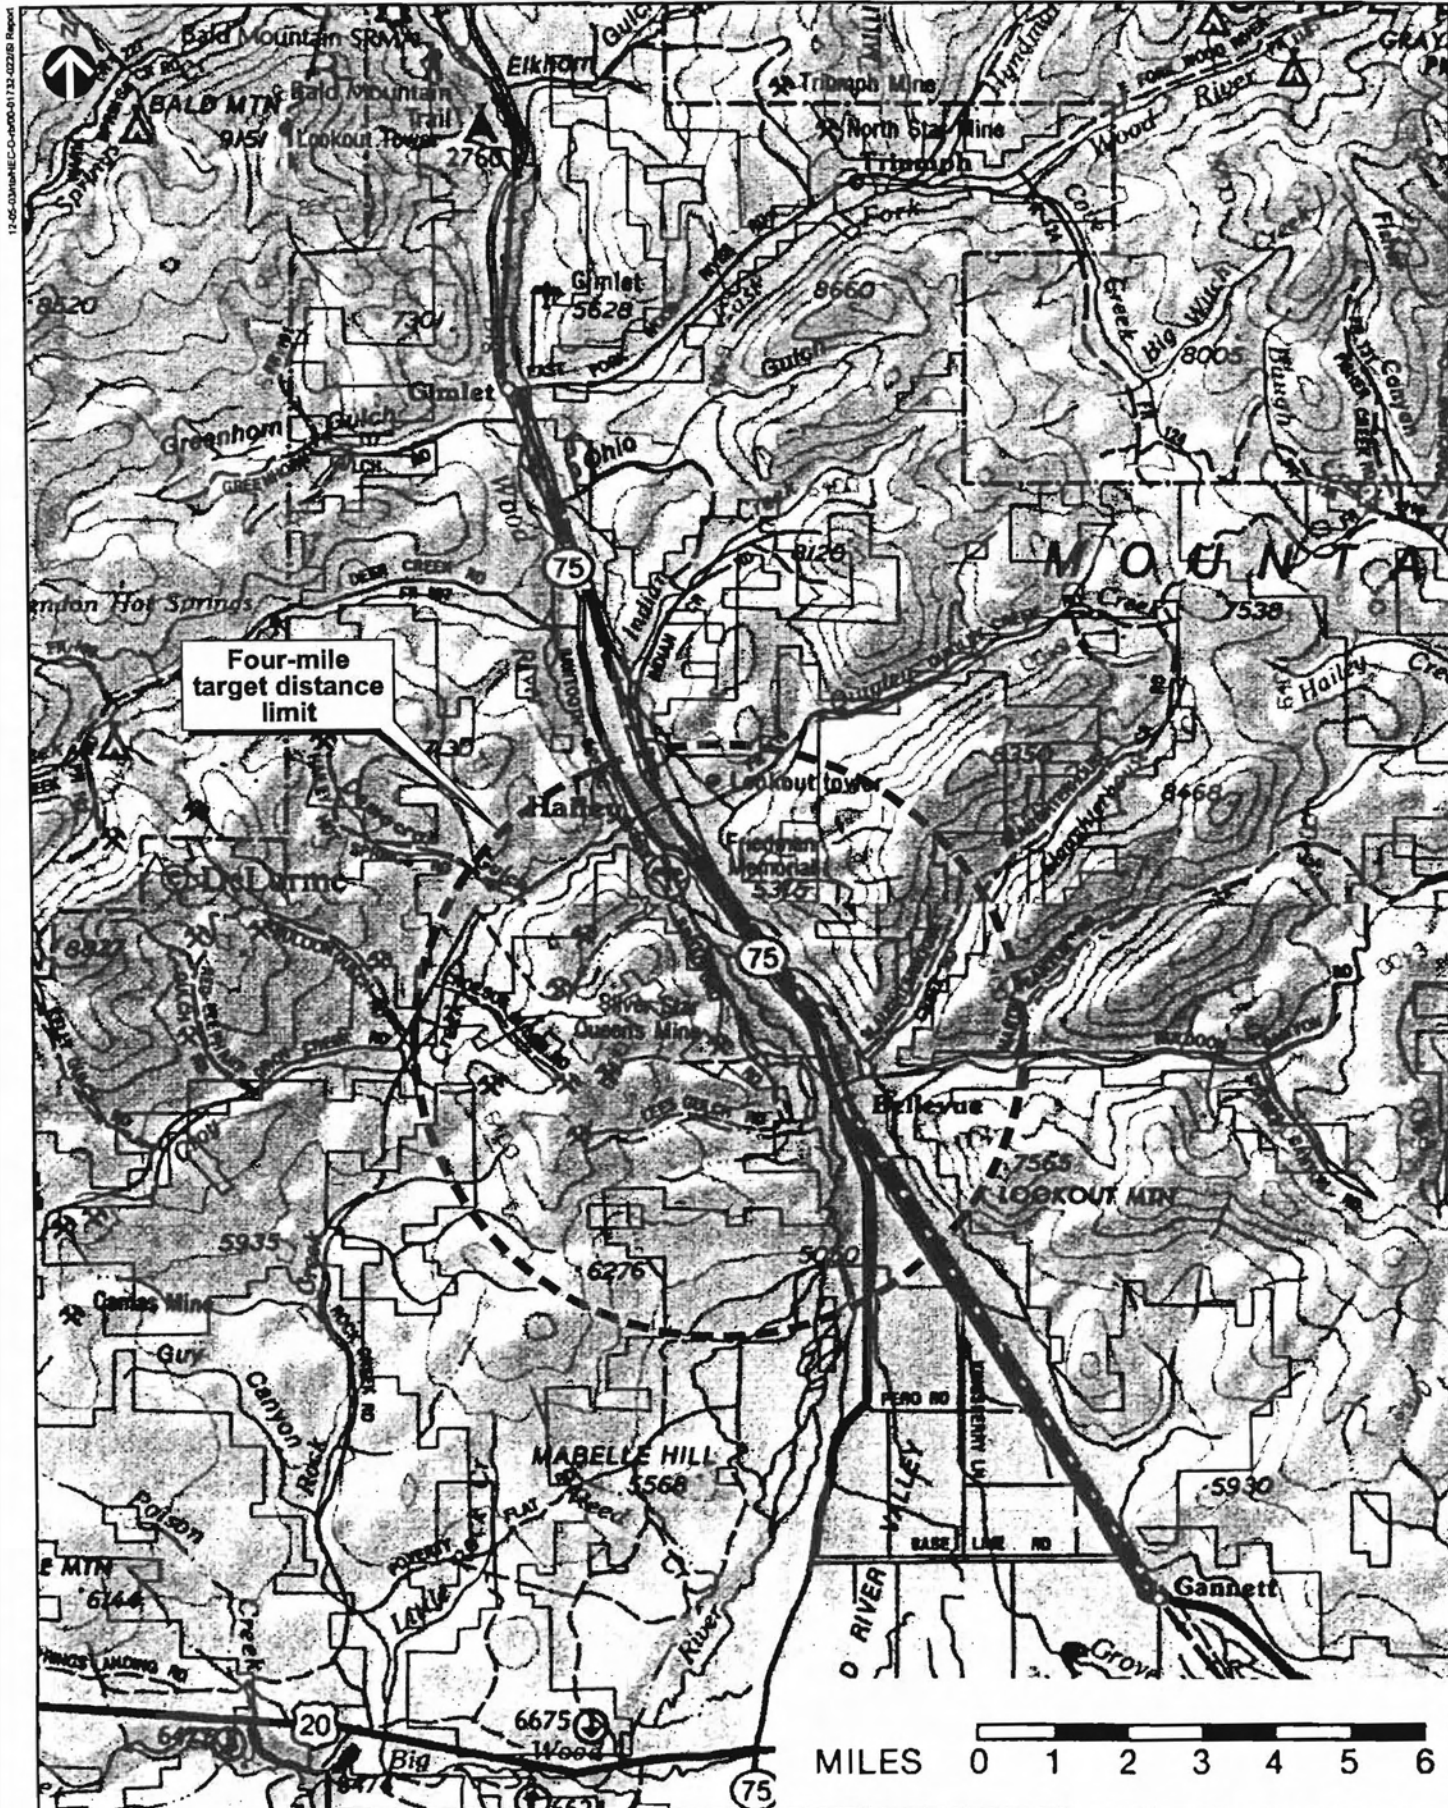
Figure 7-1. Four-mile target distance limit map of the Minnie Moore mine site, Blaine County, Idaho.

One hundred and forty-one domestic drinking water wells are known to exist within a 4-mile radius of the site; the nearest is located on site (EPA 2002a). Based on an average of 2.40

persons per household in Blaine County (USCB 2000), these wells serve approximately 338 people. The City of Bellevue operates one municipal well located between ½ and 1 mile from the site, that serves 850 households, or an estimated 2,040 persons. The ground water drinking population served by wells within designated distance rings is provided in Table 7-1.

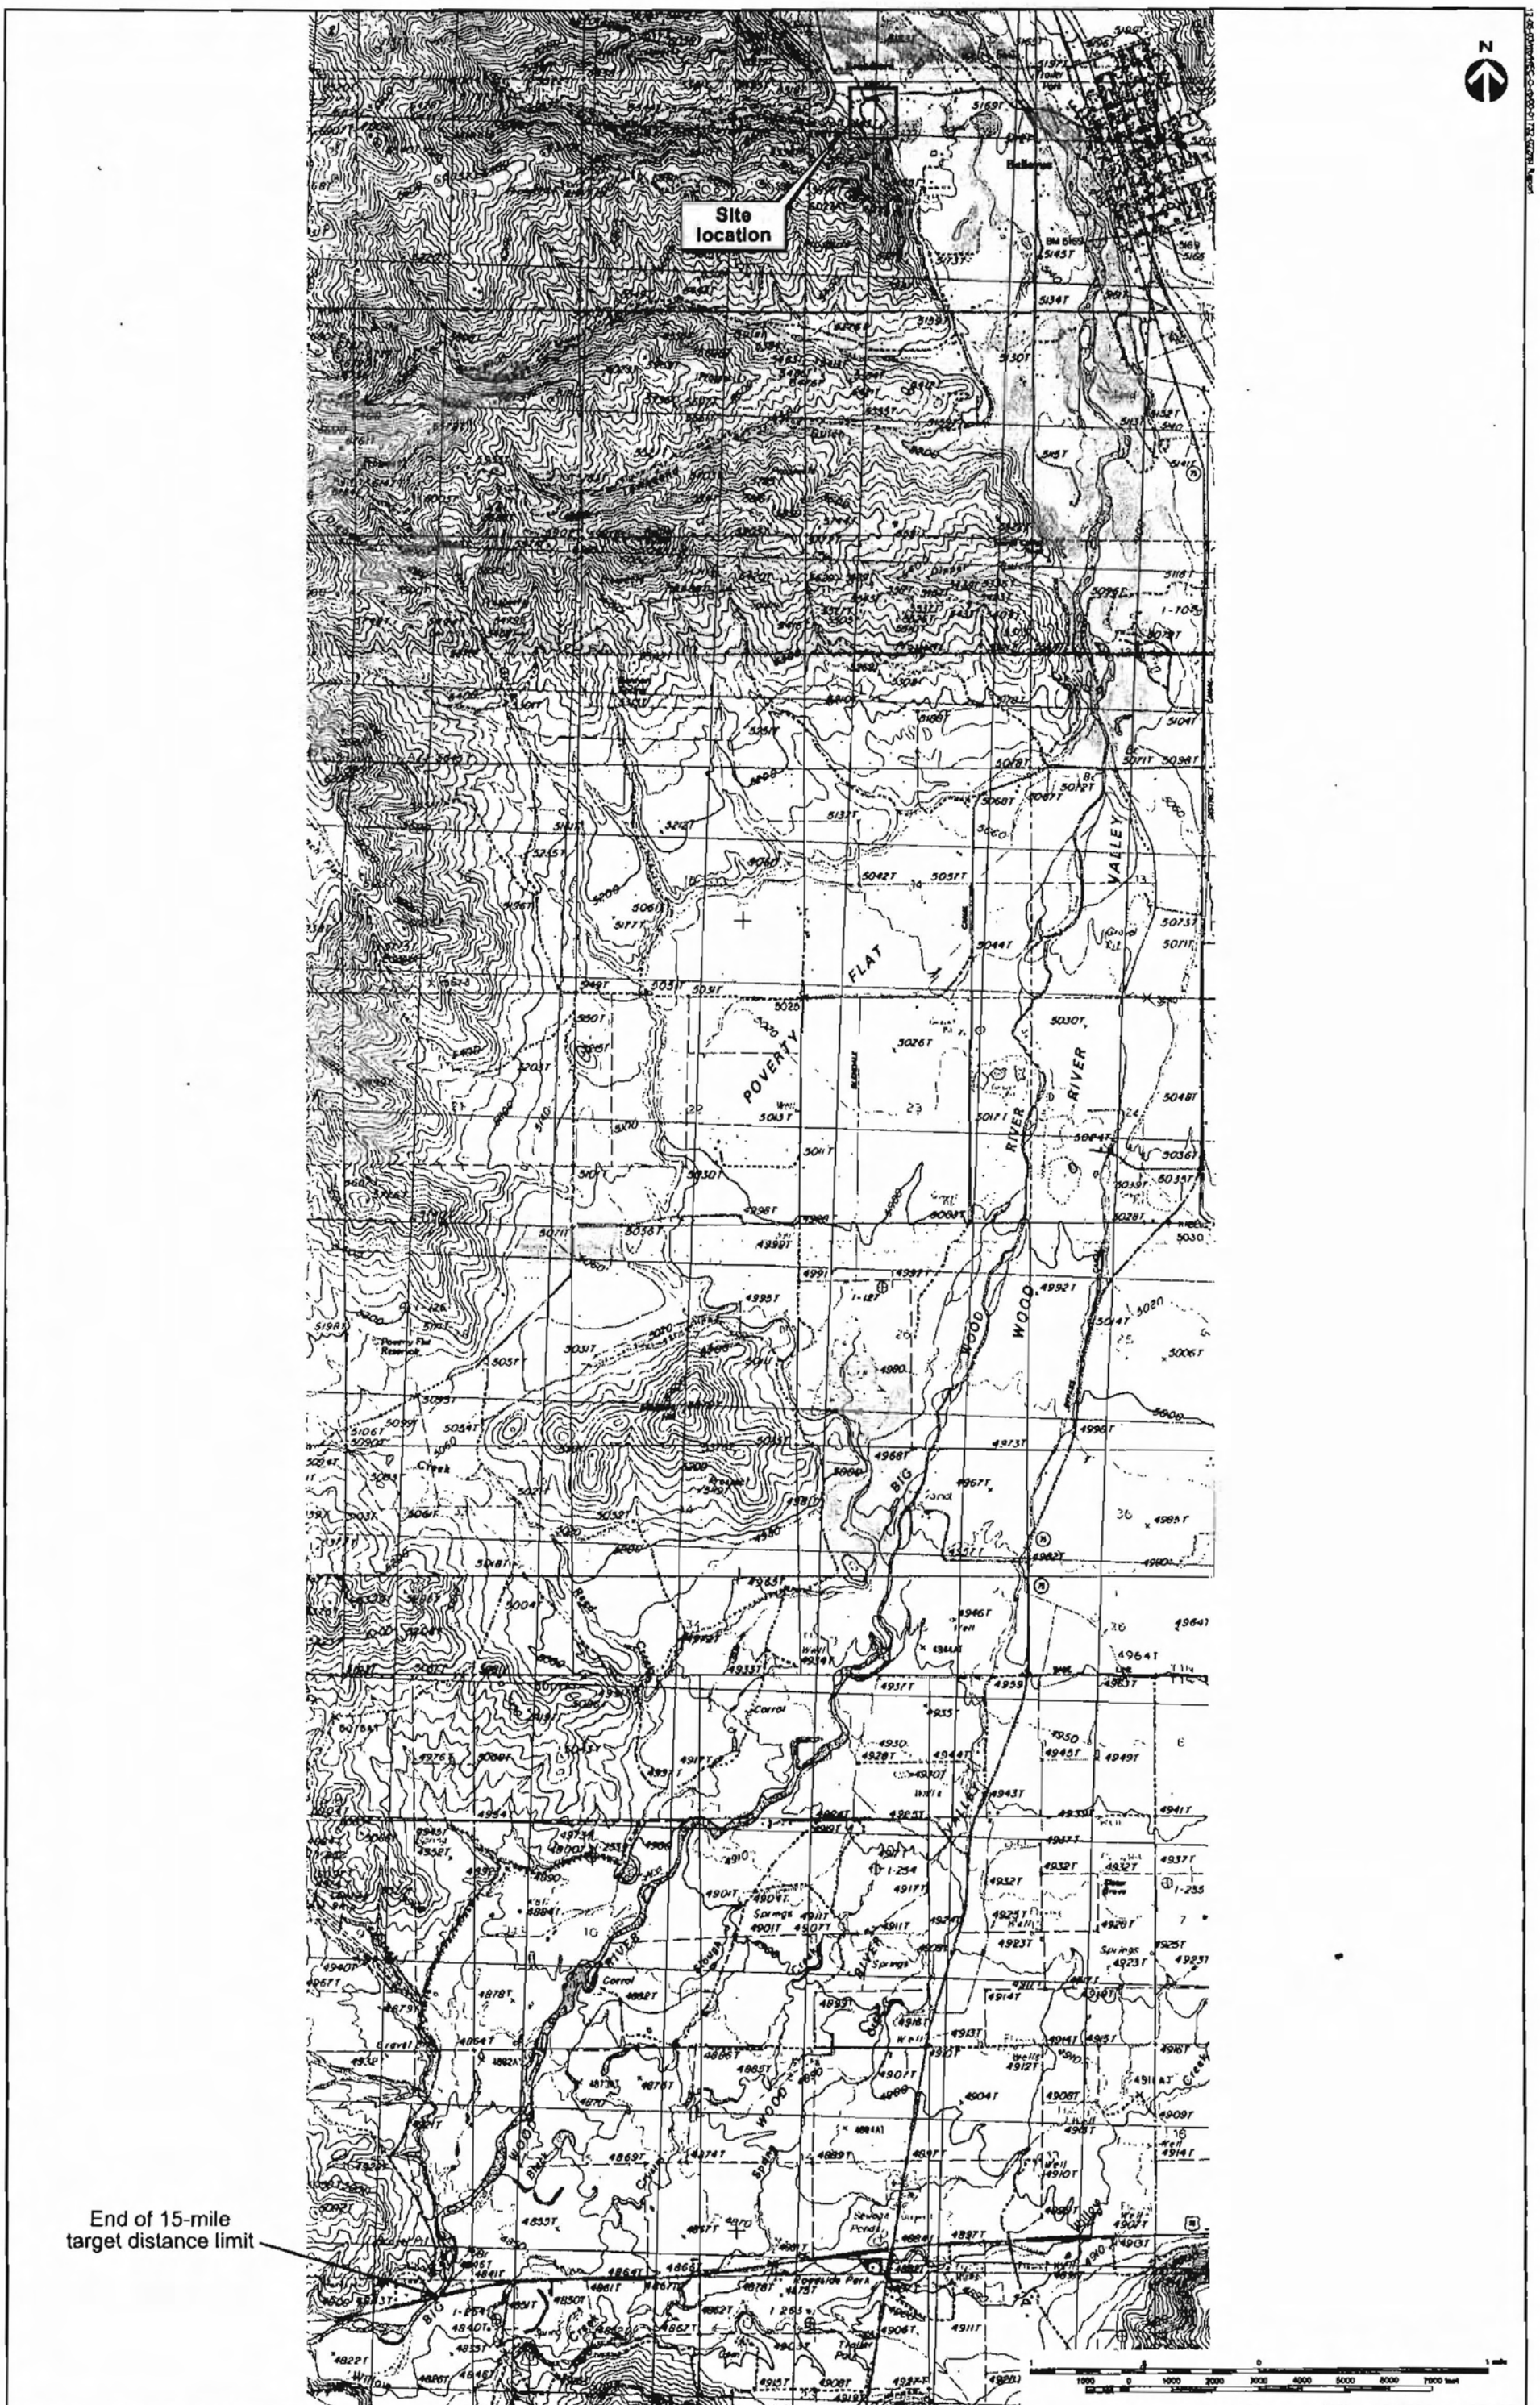
Figure 7-2. Fifteen-mile target distance limit map of the Minnie Moore Mine site, Blaine County, Idaho.

Big Wood River south of Bellevue and Broadford Slough are diverted for irrigation (EPA 2002a). Federal threatened species are believed to use portions of the TDL as habitat, but have not been observed in the last five years. The bald eagle (*Haliaeetus leucocephalus*) may winter within the TDL (ICDC 2001, EPA 2002a).

Wetlands along Broadford Slough are classified as forested, scrub-shrub, and emergent palustrine system wetlands (USFWS 1990a; USFWS 1990b), confirmed by a wetland specialist present during PA/SI field activities (based on dominant vegetation and the presence of indicator species). Pacific willow, black cottonwood, red-osier dogwood, quaking aspen, reed canarygrass, and sedges were common species observed in the vicinity of sediment sample collection locations along the slough. Forested, scrub-shrub, and emergent palustrine wetlands meet the 40 Code of Federal Regulations (CFR) 230.3 definition of an applicable wetland for Hazard Ranking System scoring purposes (EPA 1992). It is estimated from National Wetland Inventory (NWI) maps that 9 miles of wetland frontage exist along the surface water TDL.
