**RED ELEPHANT MINE
PRELIMINARY ASSESSMENT REPORT
BLAINE COUNTY, IDAHO**

**STATE OF IDAHO
DEPARTMENT OF ENVIRONMENTAL QUALITY**

December 2002

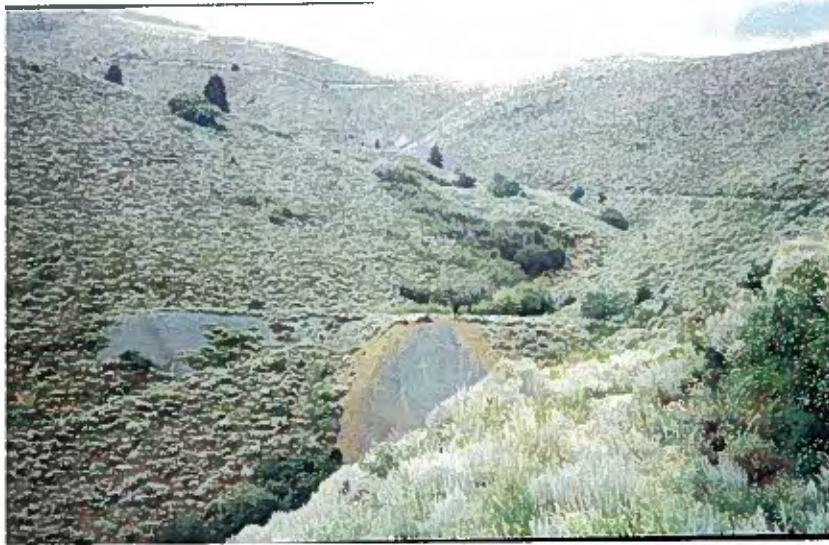
Photo 1. Red Elephant Gulch, Dump #3. (NNW)

The following is a description of the upper Red Elephant Gulch workings encountered during the site visit. Adit #3 apparently constituted the #6 level of the Red Elephant Mine. Adit and Dump #4 were the next prominent and higher mine features. A wooden ore bin still stands at the toe of Dump #4 (Photos 2 and 4). The entrance to Adit #4 (Photo 2) was partially caved, and blocked by a wooden gate. Adit and Dump #5 (Photo 5) were located just above Adit and Dump #4. Dump #5, while not as large as Dump #4, was still one of the larger dumps in upper Red Elephant Gulch. The adit entrance was driven into competent rock and only partially blocked and the gate was open (Photo 6). Adit and Dump #6 were located just above Adit and Dump #5. Adit #6 was collapsed and the associated waste rock dump was smaller than the previously described dumps. At the time of the DEQ site visit, none of the upper adits exhibited groundwater discharge to Red Elephant Gulch.

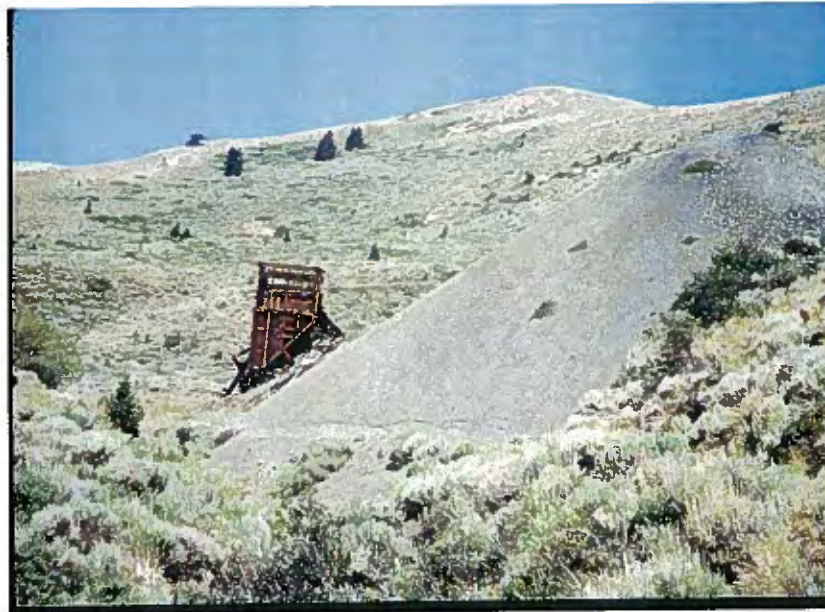
Photo 2. Ore bin and Dump #4. (NW)

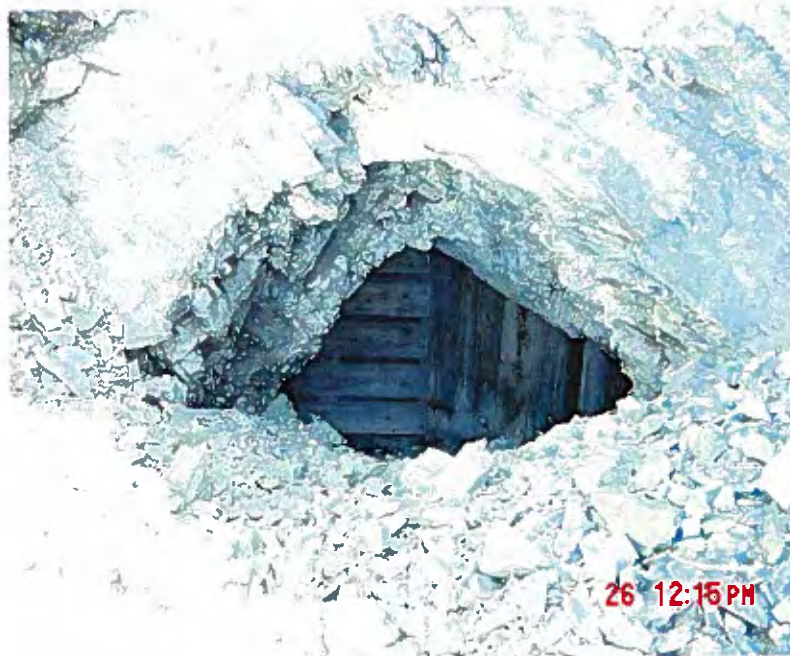
Photo 3. Close-up, Adit # 4 (NW)

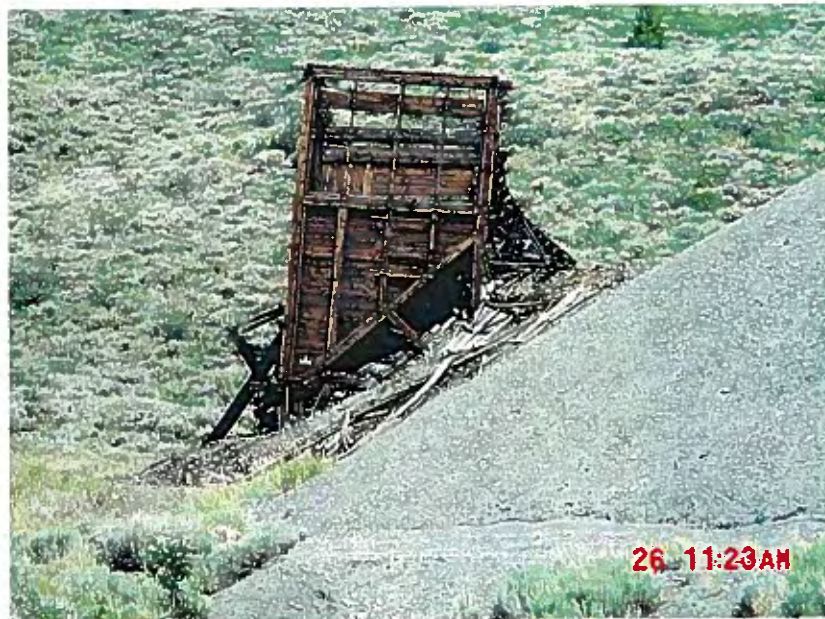
Photo 4. Close-up of ore bin at Dump #4. (NW)

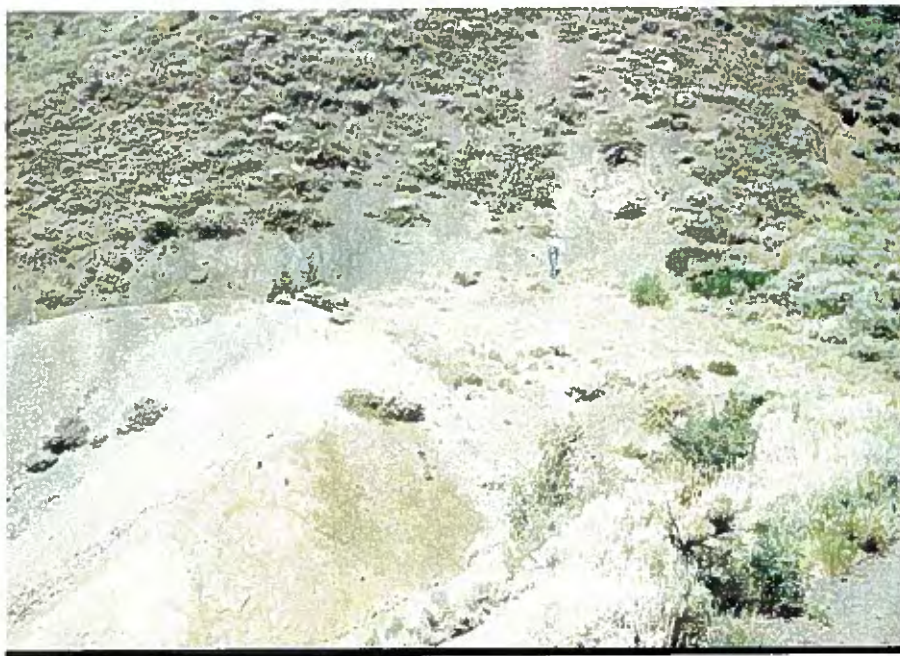
Photo 5. Adit and Dump #5 (NW)

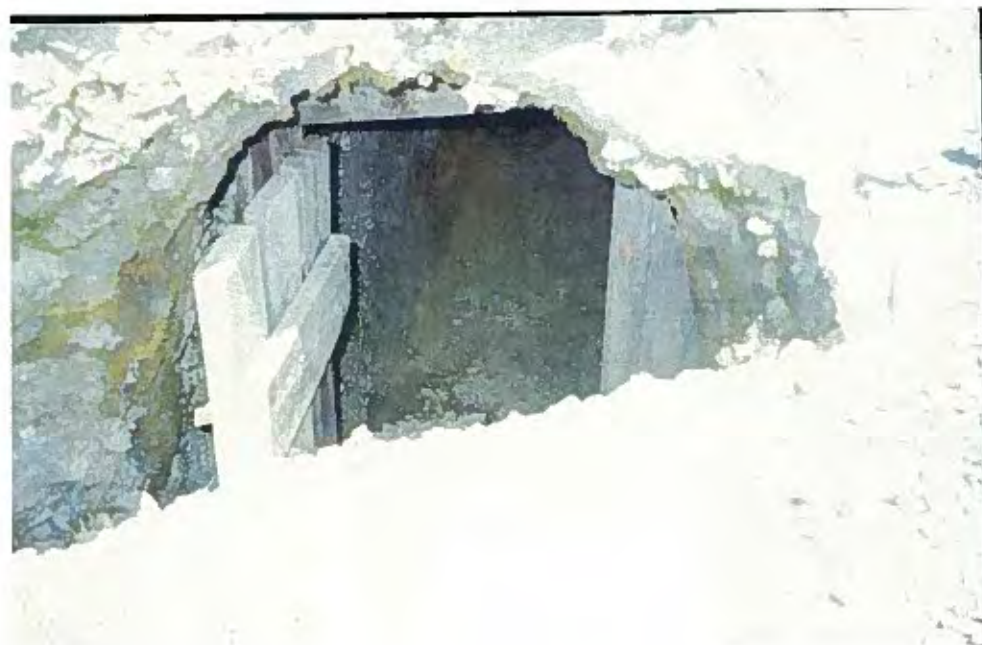
Photo 6. Close-up of Adit #5. (N)

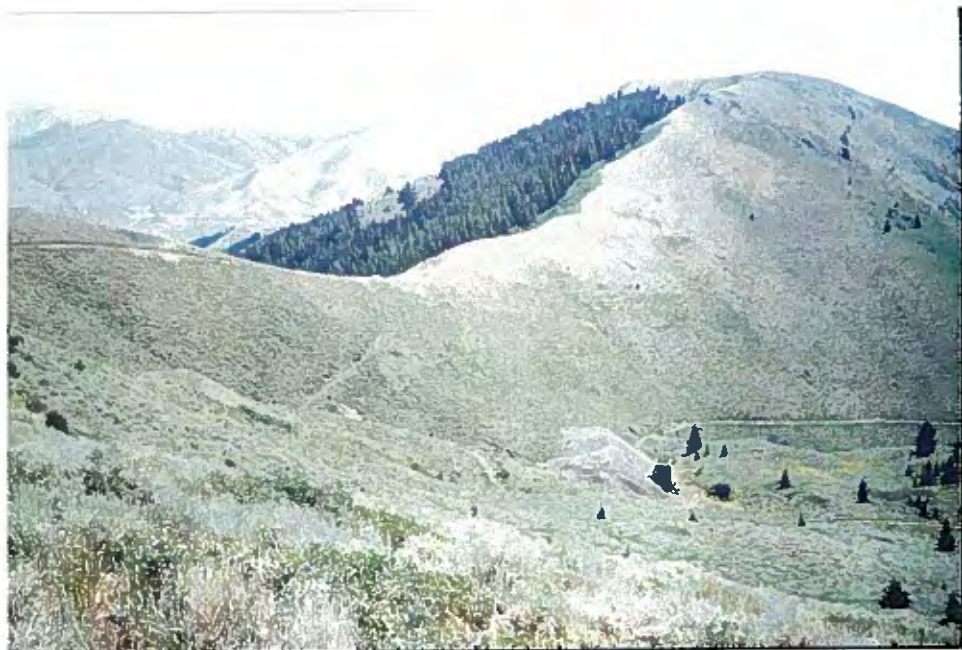
Photo 7. Near top of ridge, overlooking Dumps # 4 and #5, and looking towards Bullion Gulch. (SE)

The remainder of the upper site (Adit #6 to the ridge crest forming the divide between Red Elephant and Bullion Gulches) consisted of a series of prospect holes and associated small waste rock piles. At the mouth of Red Elephant Gulch DEQ identified a waste rock dump and portal located east from Elk Creek. The adit was apparently known as the "Lipman Tunnel" (Gillerman, 1990), or the "Red Elephant Consolidated Tunnel" (Umpleby, 1930). The adit collapsed beyond the portal creating a sinkhole. The exposed country rock and waste rock were thin-bedded shale and limestone. Drainage emanated

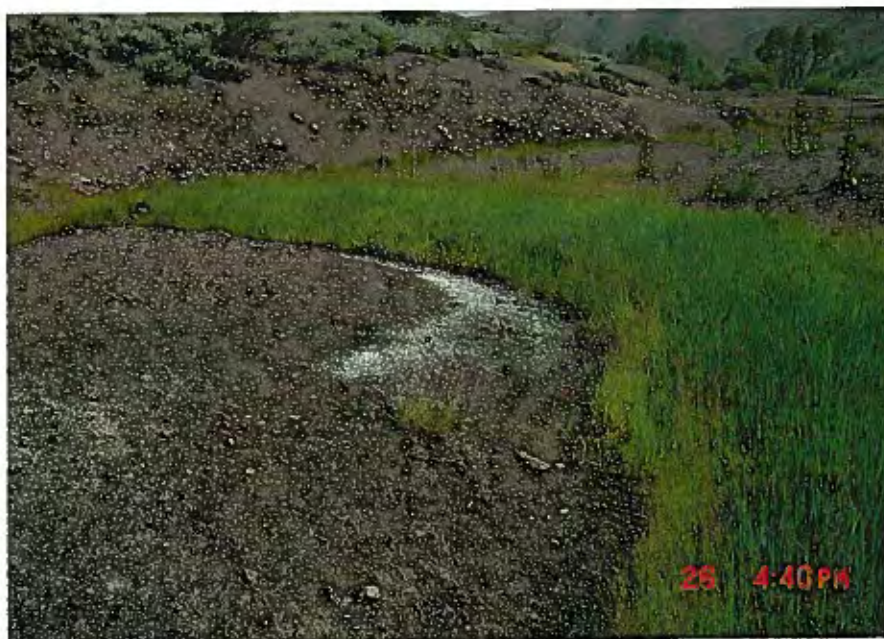
Photo 8. Elk Creek tailings, upstream of Red Elephant Mill site. (SE)

DEQ collected three representative samples from the tailings (Appendix B); two from the tailings impoundments above the mill site and one adjacent to the mill site but, on the opposite side (west) of Elk Creek. The composite samples were representative of the coarse and fine fractions characteristic of the tailings. Total metals analysis of the tailings samples indicates risk levels at or below 1×10^{-6} (or one in 1,000,000) for cadmium, silver and two samples for mercury, conservatively assuming an industrial exposure scenario. Using the same exposure scenario, one mercury sample (1.0×10^{-5}) and three lead samples (ranging from 1.8×10^{-5} to 2.5×10^{-5}) demonstrated slightly higher risk (EPA¹, 2002). Lead ranged from 14,200 mg/kg to 18,400 mg/kg in the samples.

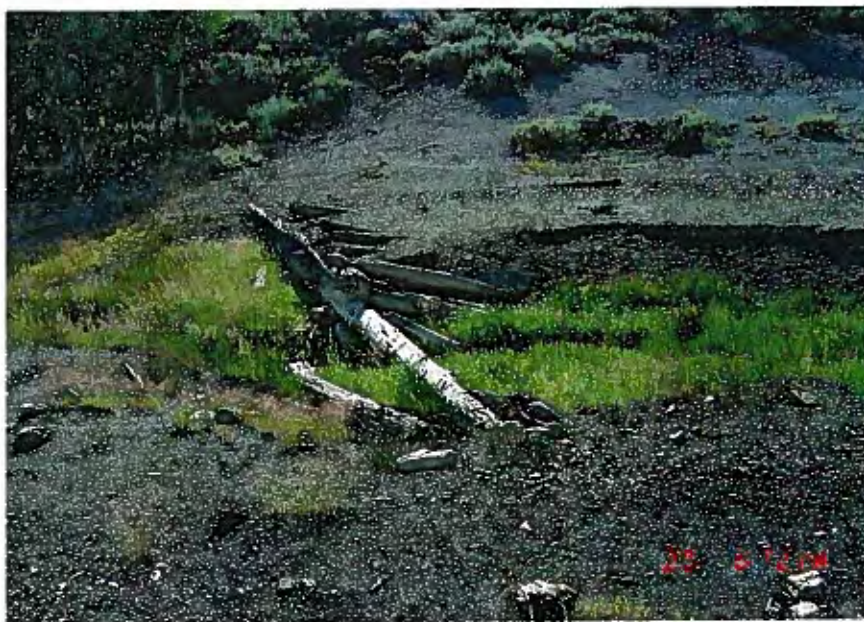
Photo 9. Tailings Dam in Elk Creek. (W)

The tailings impoundments (above and below the mill site) exhibited a strong binding characteristic while the waste rock dumps appeared consolidated with minor amounts of fine-grained material. Based upon direct observation, the likelihood of aerial dispersion from either of these sources appears minimal.

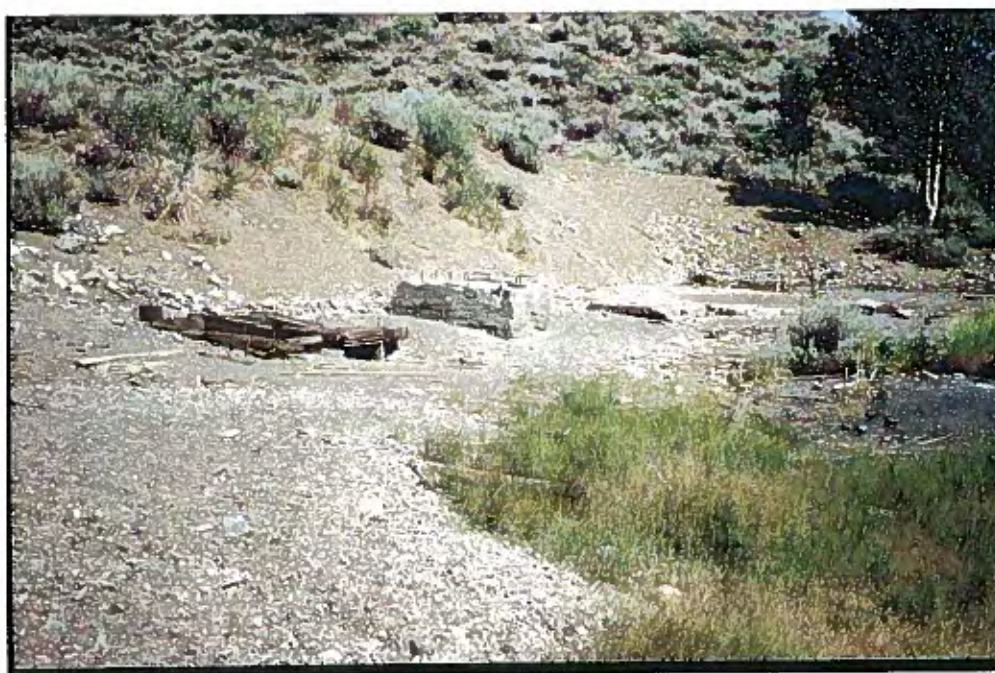
The Red Elephant Mill site and tailings were located downstream from the Lipman Tunnel. The mill site (Photo 10) consisting of a concrete foundation approximately 100 feet long by 60 feet wide, was located approximately 0.5 miles above the junction of Elk Creek and Croy Road at about 5990 feet amsl (USGS, 1986). Tailings (Photo 8) and the remains (wooden timbers) of several earthen tailings dams (Photo 9) were located above and below the mill site. Mitchell and Gillerman described the tailings as "approximately one-half mile long, 150 feet wide, and with an average of 3 feet deep" (1999, p.8). Elk Creek dispersed the tailings throughout the drainage. The tailings appeared light to dark gray and coarse at the surface. Tailings away from and less influenced by flowing water were more uniformly dark gray and fine to very fine-grained, especially several inches beneath the surface. Vegetation was sparse over a significant portion of the tailings.

Photo 10. Red Elephant Mill foundations and tailings; the channel of Elk Creek flows just to the right (W) and out of the photograph. (SE)
