Re: Limited Subsurface Investigation at Rescue Mine, located near Warren, Idaho.

## SITE PLAN WITH SAMPLE LOCATIONS

RESCUE MINE  
WARREN, IDAHO

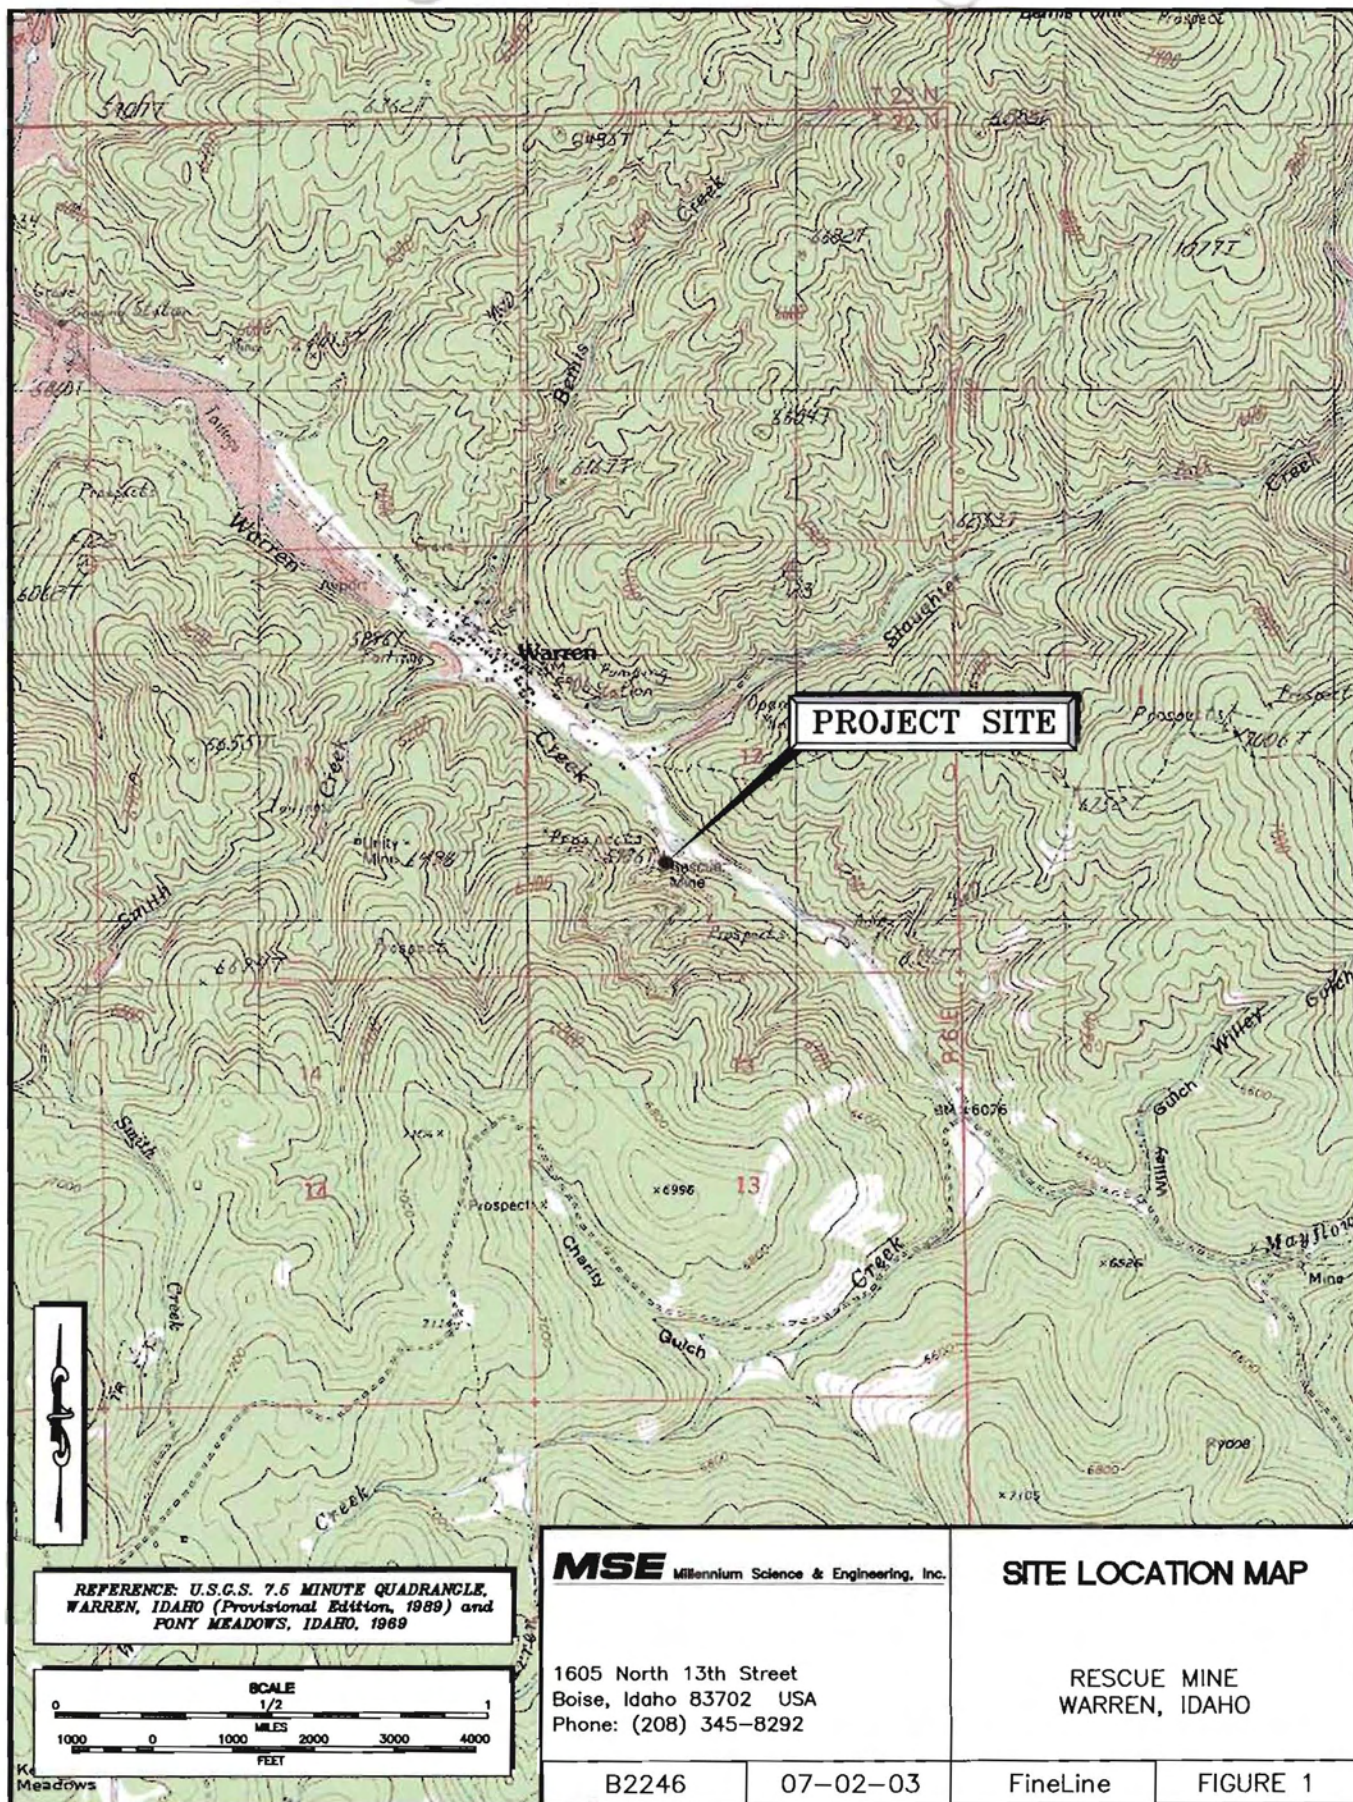
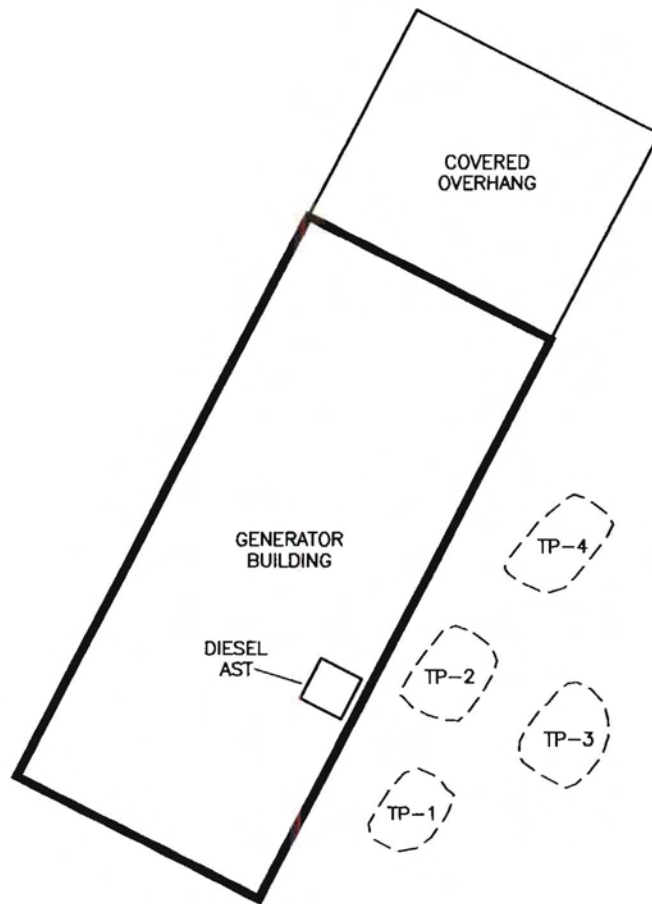
FIGURE 2

Five test pits were excavated in the vicinity of the Generator Building using a backhoe (Test Pit 1 through Test Pit 4, and Test Pit 6) to a maximum depth of 5 feet below ground surface (BGS). Test pit locations are identified in Figure 2 and were selected in the field by MSE personnel. Photographs of site activities are included in Appendix 1. Soil samples were collected from the test pit areas at discrete depth intervals and were field screened for petroleum hydrocarbons using a portable photo-ionization detector

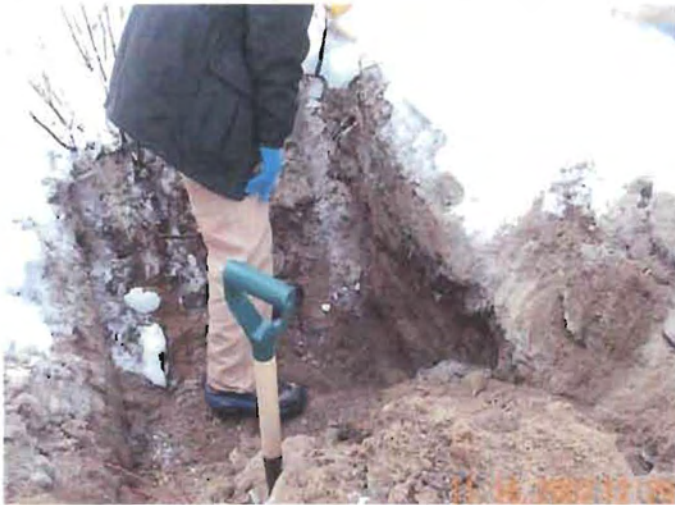
Results of field screened petroleum hydrocarbon concentrations measured with a PID are presented in Appendix 2. No soil impacts were found in Test Pit 1. PID results indicated that diesel impacts appear to be limited to shallow subsurface soil in the vicinity of Test Pits 2, 3, and 4 and petroleum hydrocarbon concentrations decrease with increasing depth BGS along the outer (eastern) fringe of the soil contamination. The location of the diesel AST within the Generator Building limited the access to soils directly beneath the AST and to the north and west.

**Photo 1:** Looking into Pit #1. Note stain boundary on material about halfway down pit wall.

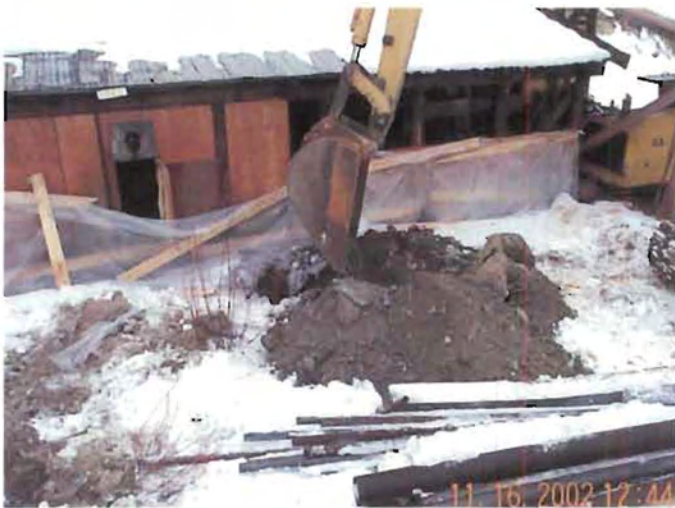
Four soil samples were collected during the assessment and were submitted for laboratory analysis of BTEX and PAH's (Tables 3 and 4). Soil samples collected from Test Pit 2 at five feet BGS, Test Pit 3 at six feet BGS, and Test Pit 4 at four feet BGS were below laboratory detection limits for BTEX and PAH's. The soil sample collected from Test Pit 2 at two feet BGS had elevated concentrations of BTEX and PAH's, indicating soil in this area has been impacted by a release from the diesel AST. Reported concentrations for total xylenes, acenaphthene, fluorene, naphthalene, and phenanthrene for this sample exceeded Idaho Risk Based Corrective Action (RBCA) Tier 0 Soil Cleanup Levels for Petroleum Releases.

**Photo 2:** Pit #2 directly adjacent to surface ponding stain.

An alternative to further site characterization could include excavation of impacted soils as part of a proposed corrective action. This approach could be used to define the lateral and vertical extent of contamination during removal of impacted soils. Given the location of the Generator Building, this would likely require hand excavation of impacted soils within the Generator Building with limited excavation directly beneath the diesel fuel AST and walls of the structure. Following soil removal, samples for laboratory analysis would be collected from the vertical and lateral extent of the excavation. Samples would be analyzed for BTEX and PAH constituents. Samples of groundwater would be collected (if encountered). Excavated soils would be placed in a one foot thick lift in a DEQ approved landfarm located on-site. The design of the landfarm would follow DEQ protocol and may include placement of plastic sheeting and a bermed perimeter to prevent surface water run-on/run-off. The soils would be periodically aerated to promote biologic degradation of petroleum compounds. Following treatment, samples of the landfarmed soils would be collected for laboratory analysis to confirm clean-up goals have been met and suitability of the site for closure.

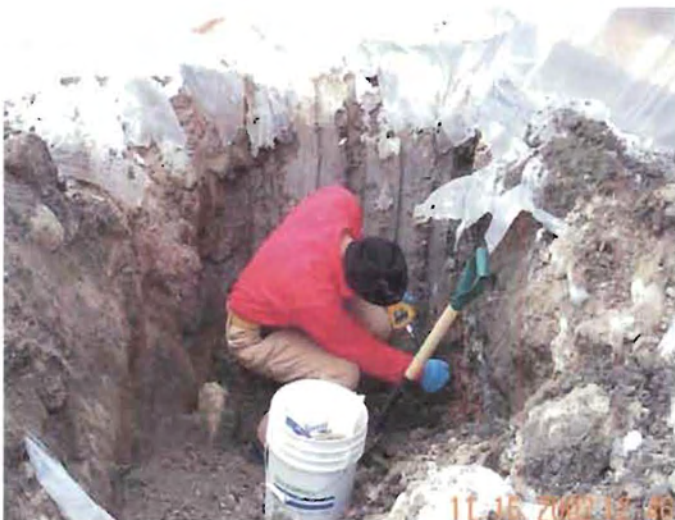
**Photo 3:** MSE Employee using PID on wall of Pit #2.

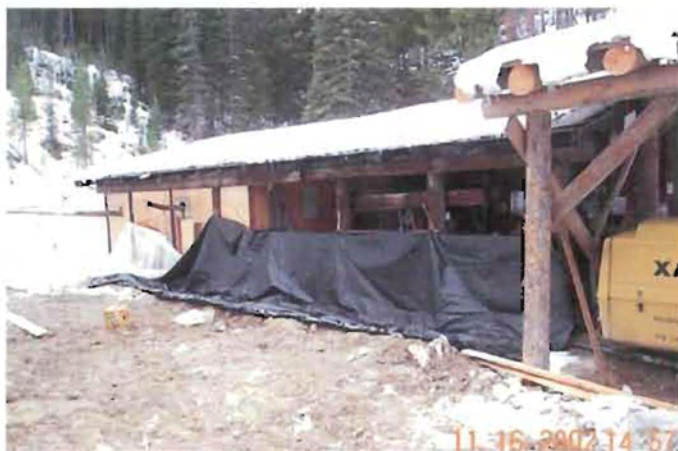
**Photo 4:** Pits filled in and pond liner placed against wall and over main concentration of spill. Sloped to drain toward front of building.

Four soil samples collected from the test pits were submitted to Alchem for laboratory analysis of BTEX by EPA method 8020 and PAH's by EPA method 8270. Soil laboratory analytical results for BTEX are reported in Table 3 and PAH results are reported in Table 4. Copies of laboratory analytical reports and chain-of-custody forms are included in Appendix 3. Potentially impacted soil removed from the test pits was returned to the original test pits following the collection of soil samples. Groundwater was not observed in the excavation during subsurface assessment activities. Following field activities, plastic sheeting was placed over the eastern side of the Generator Building to reduce surface water infiltration (snowmelt) in the impacted area.

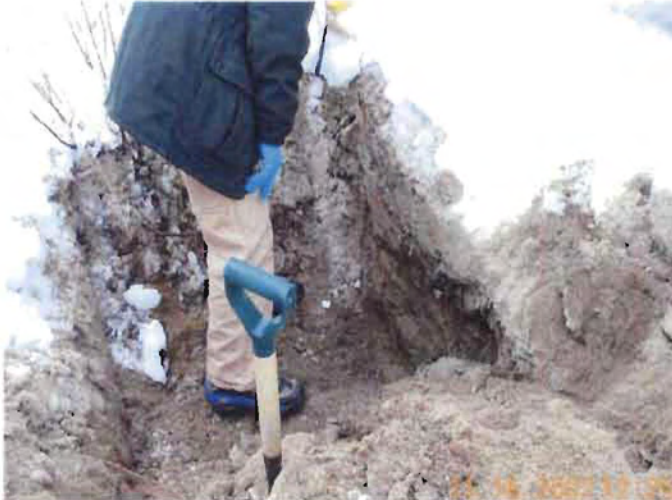
**Photo 1:** Looking into Pit #1. Note stain boundary on material about halfway down pit wall.

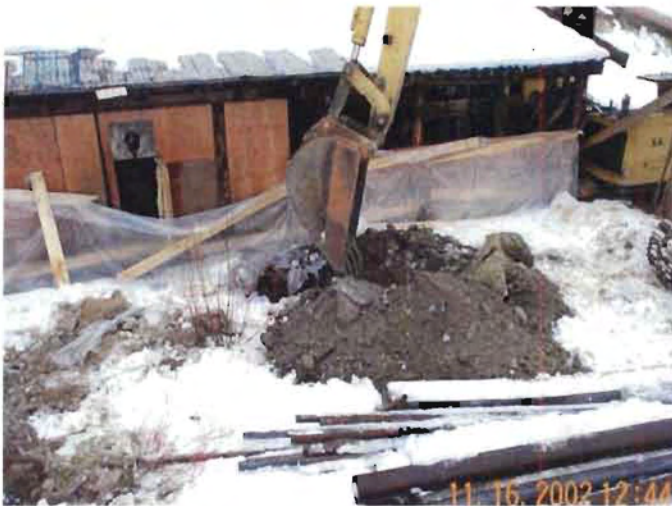
**Photo 2:** Pit #2 directly adjacent to surface ponding stain.

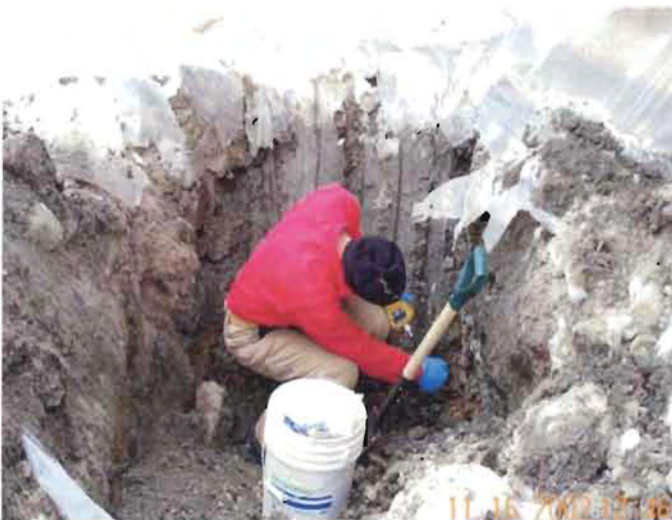
**Photo 3:** MSE Employee using PID on wall of Pit #2.

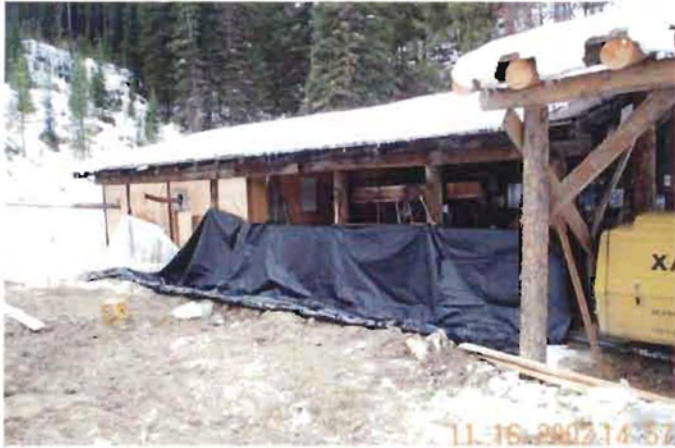
**Photo 4:** Pits filled in and pond liner placed against wall and over main concentration of spill. Sloped to drain toward front of building.
