Abbreviated Preliminary Assessment for Sawtooth MMW Property Waste Dump Area

Blaine County

**State of Idaho
Department of Environmental Quality**

December 2015

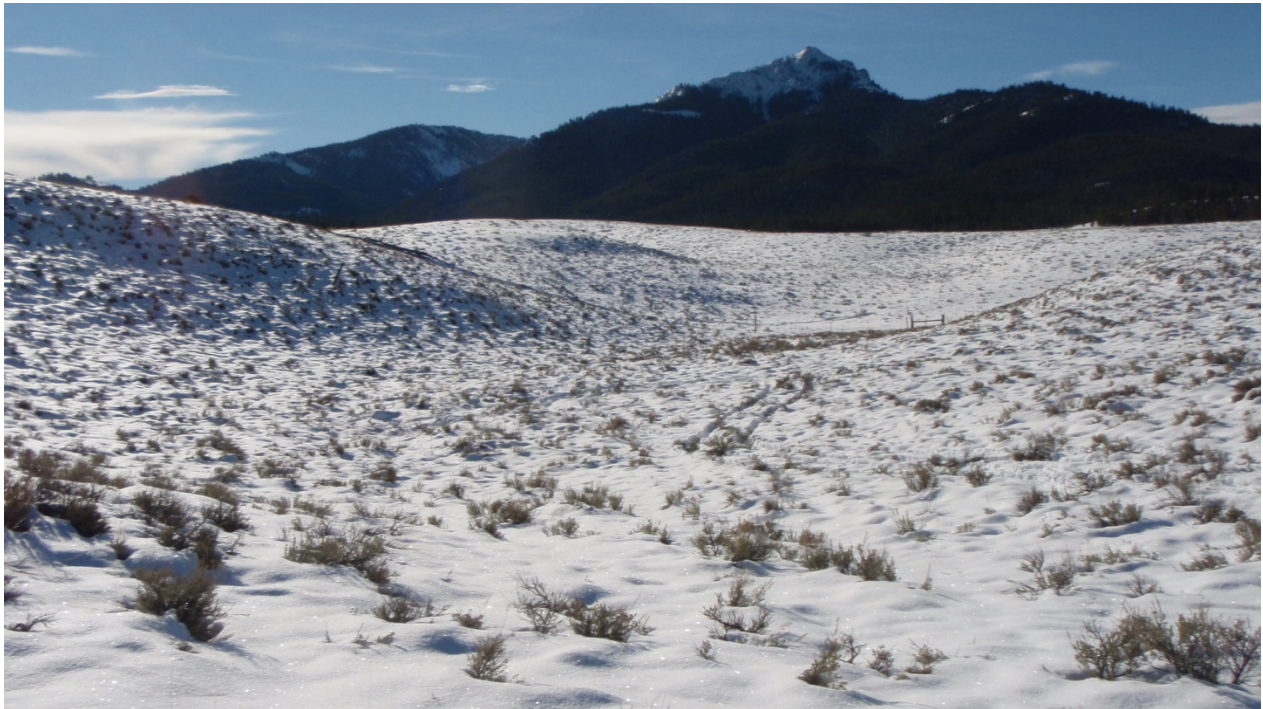
Site observations and photographs were collected during the DEQ site inspection on November 13, 2015. The weather was partly cloudy, 21°F, and snow on the ground. The waste dump is located within a topographic low area and sagebrush is growing over the area (Photos 1 and 2). While walking over the dump area, the only visible remnant is a partially unburied car bumper.

Photo 1. Location of the Sawtooth MMW Property Waste Dump Area.

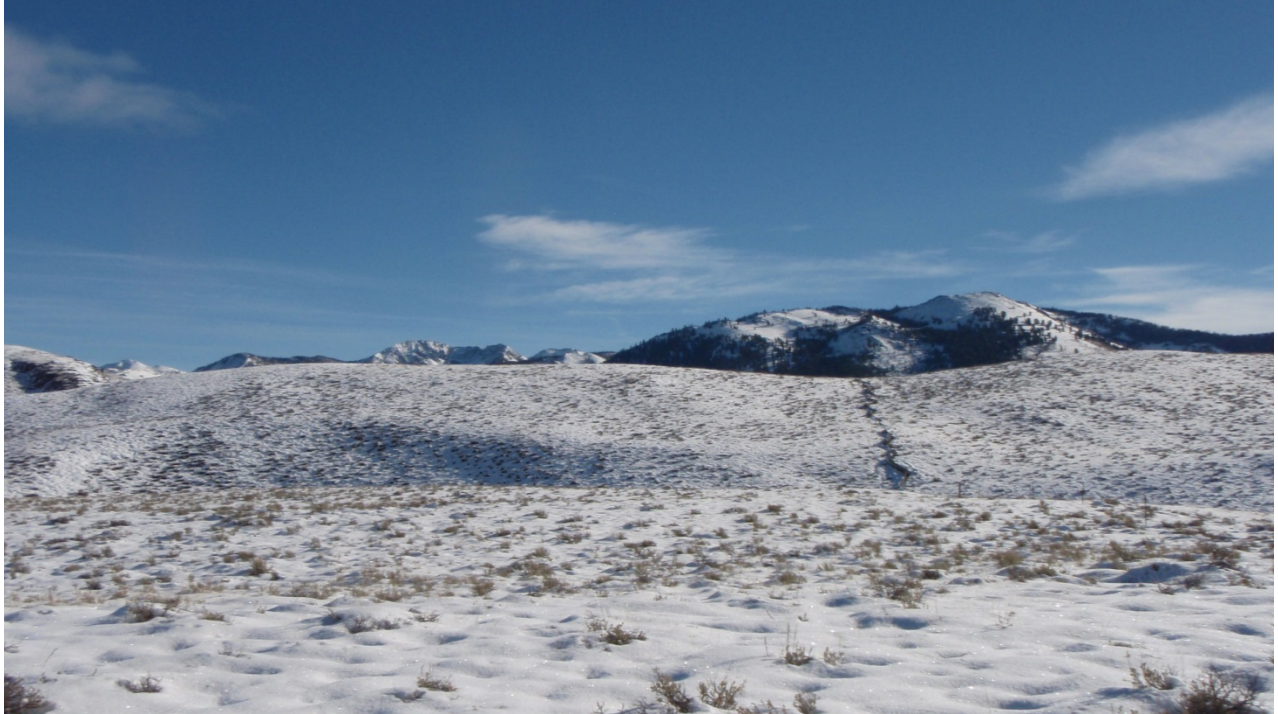
Photo 2. Looking east toward the waste dump area. Dump is within the topographic low, not visible in this photo.

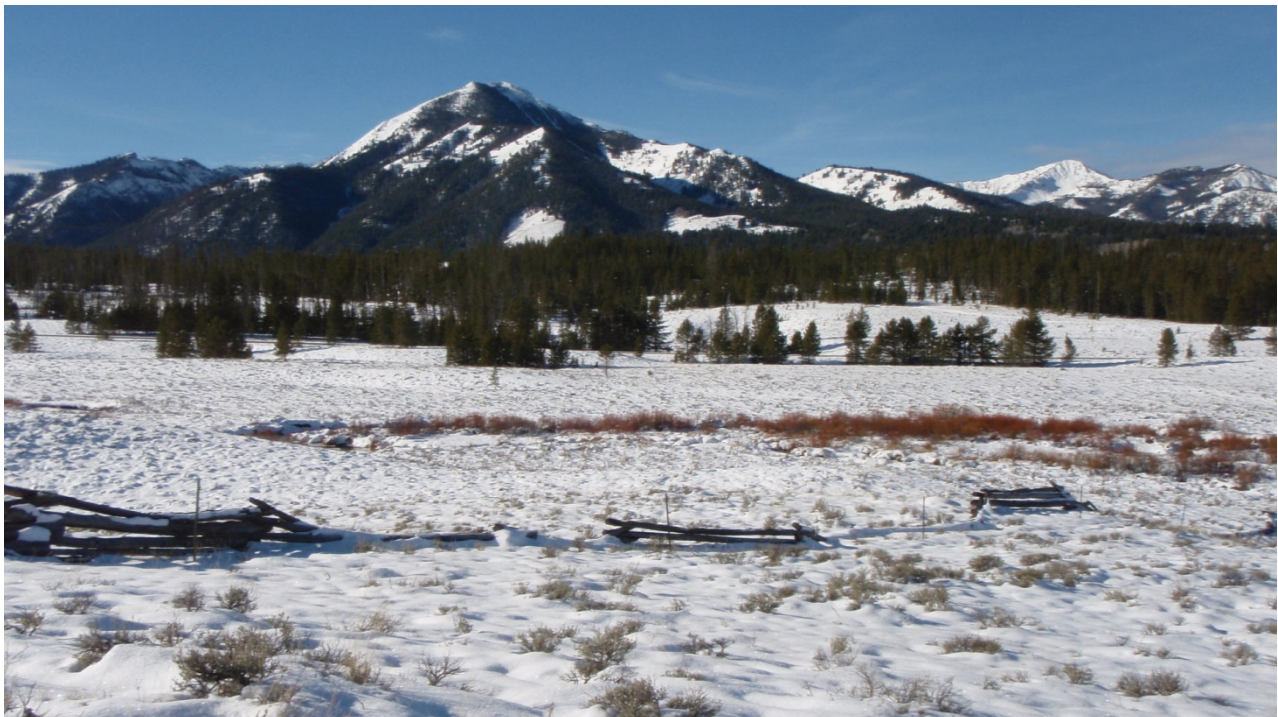
Photo 3. Looking to the southwest, toward the Salmon River from the waste dump area.
